Revival of a Stained-Glass Window

Don Pellett
as told to: Sergei Smirenski

January 15, 2026

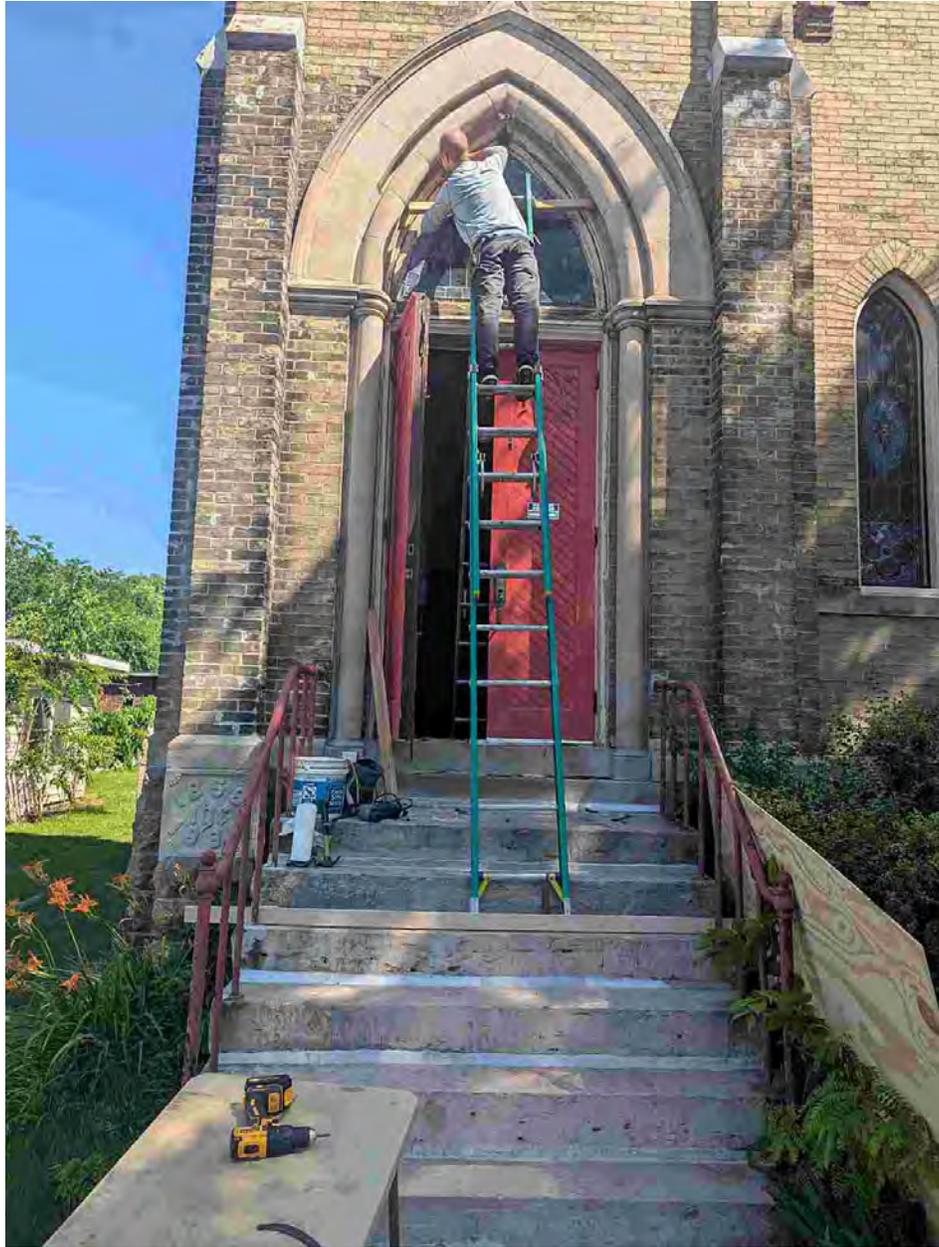
Figure 1: The project started on June 28. The risk of damaging the stained glass arose at the very first stage, when Fr. Dcn. Matthew, climbing the ladder, carefully removed the stained-glass panel. See [28 Jun](#)

- 28 Jun Remove stained glass window in frame; place temporary board in opening; 5.5 hrs [Figure 1](#)
- 02 Jul Preparation work, extend work surface, remove old putty and tacks holding glass; build sandwich boards to flip glass over; tape glass; 4 hrs

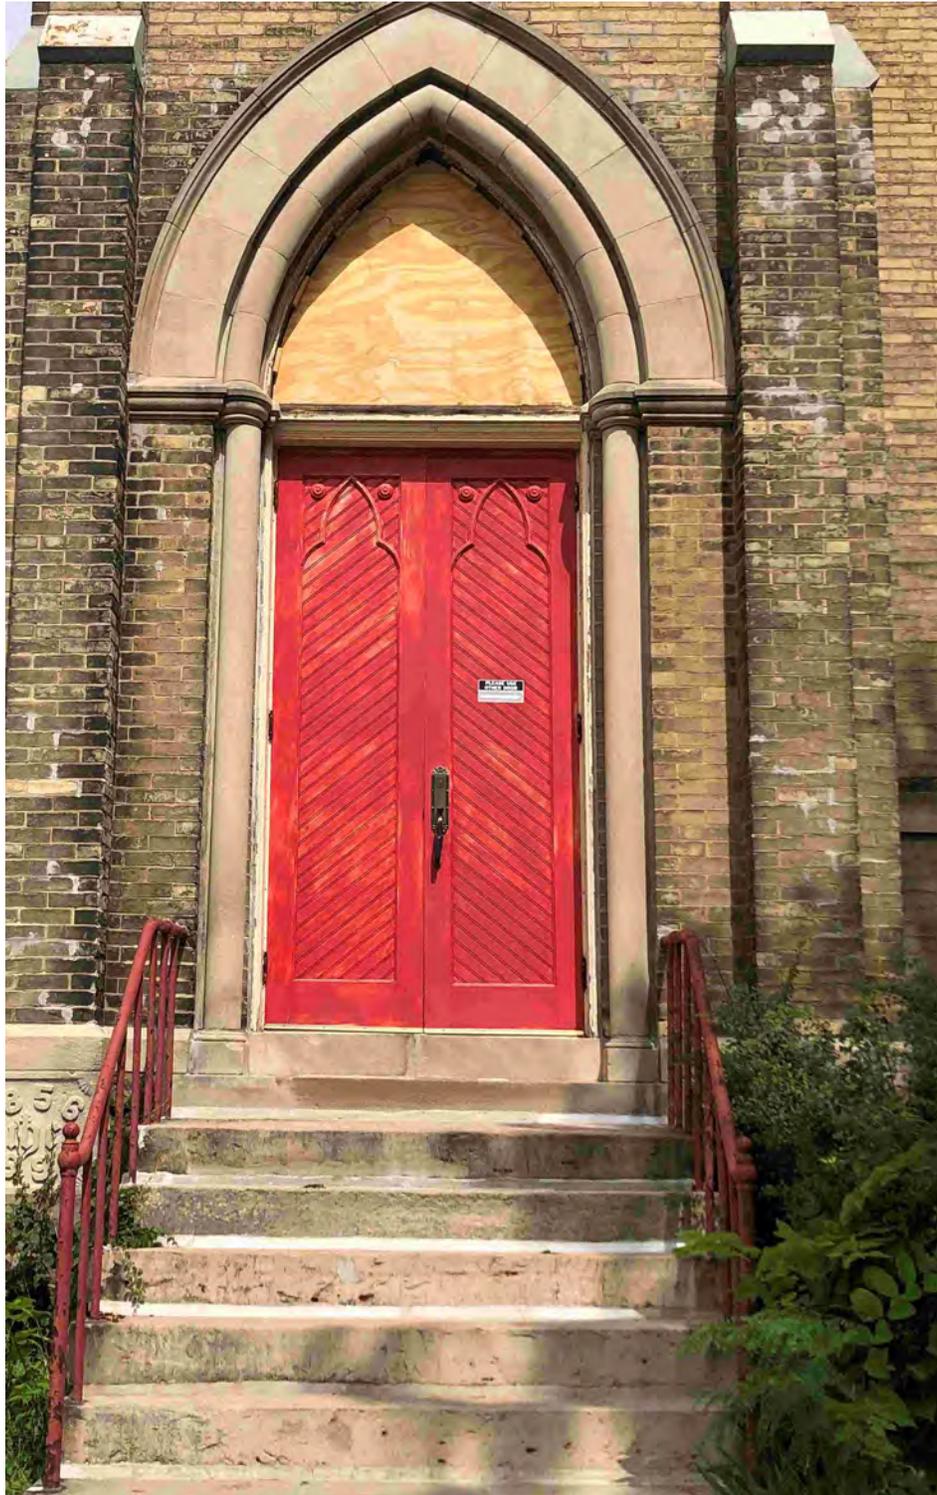
Figure 2: To protect the building from the weather, plywood was inserted in place of the stained-glass window. See [28 Jun](#)

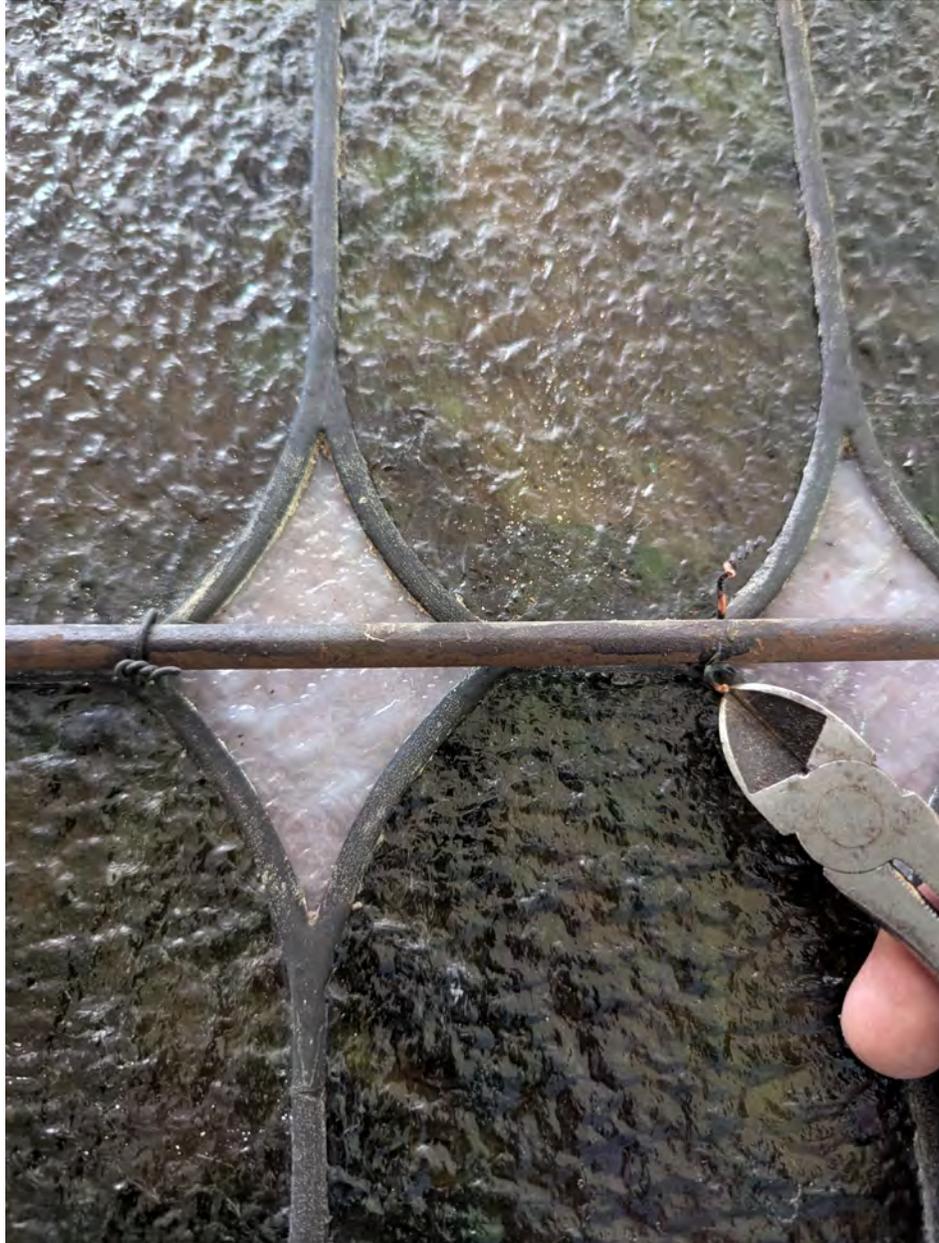
Figure 4: Don began to remove the carpet tacks from around the glass and the copper wires attached to the rebars on the interior holding the glass in the frame. See [12 Jul](#)

- 12 Jul Remove glass from frame; cut wires attached to rebars and release glass; use heat gun to clean frame of remaining putting; strip old paint to bare wood; oil bare wood; 2 hrs

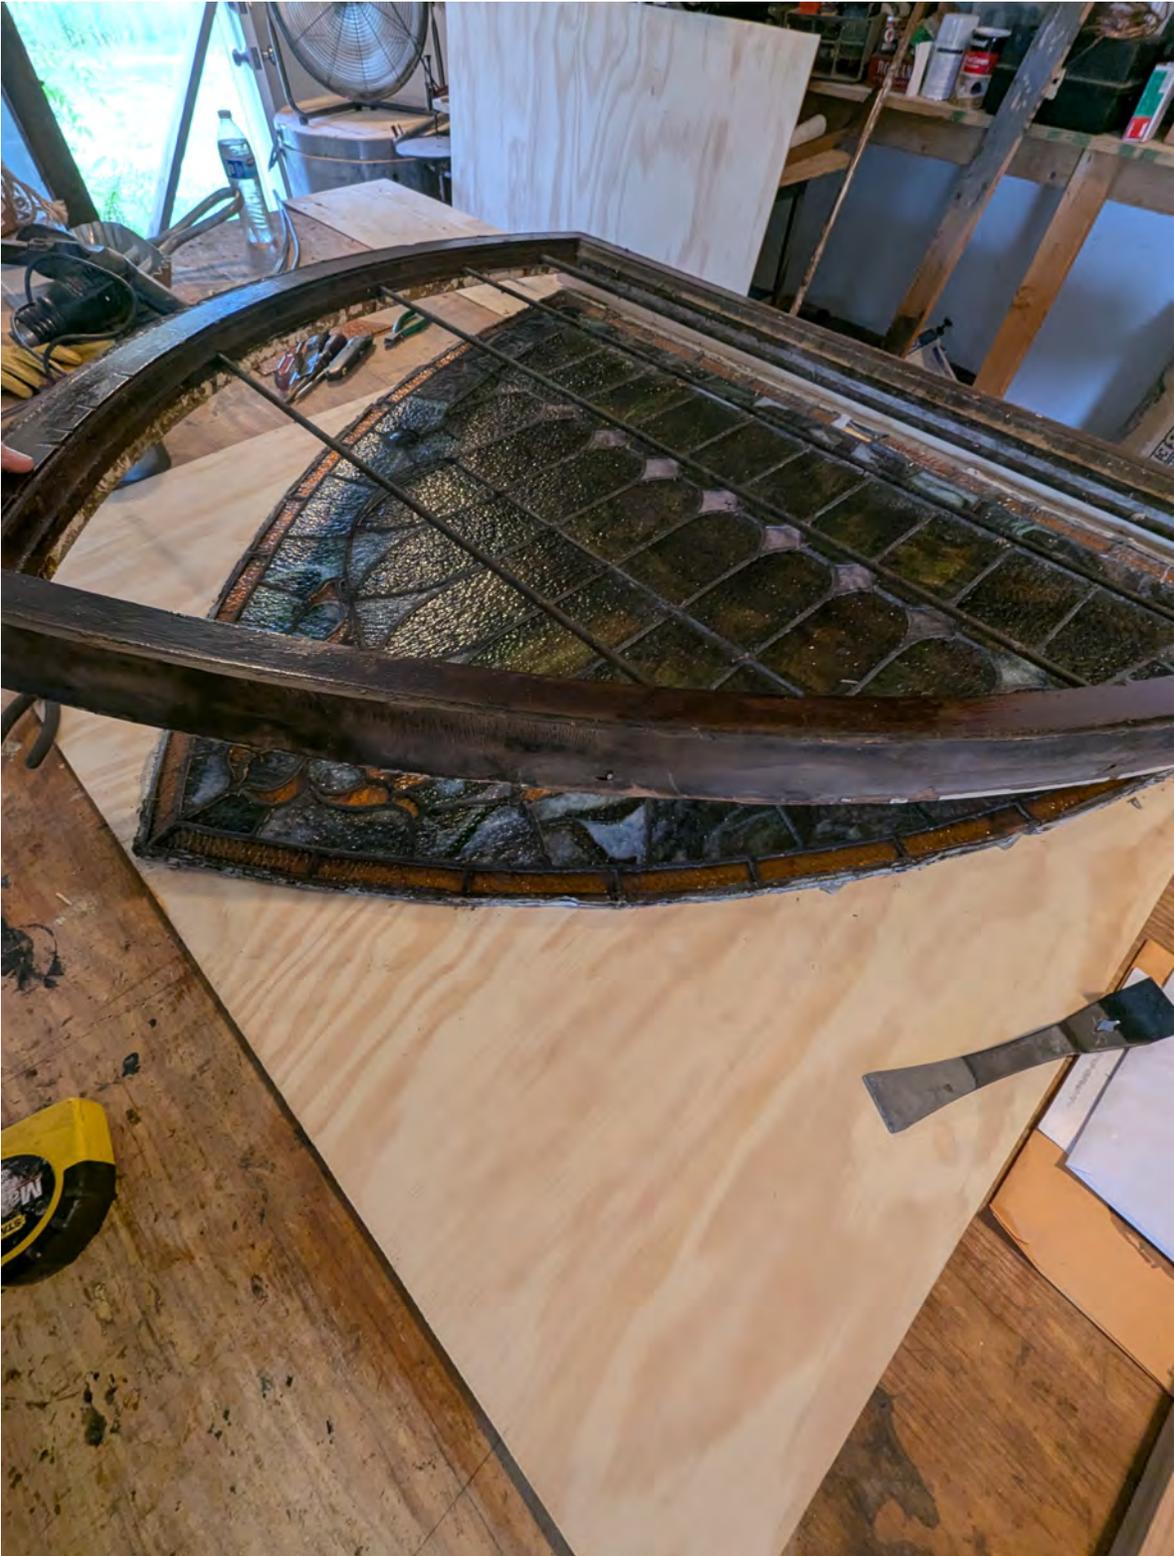
Figure 5: Separate glass from frame. See [12 Jul](#)

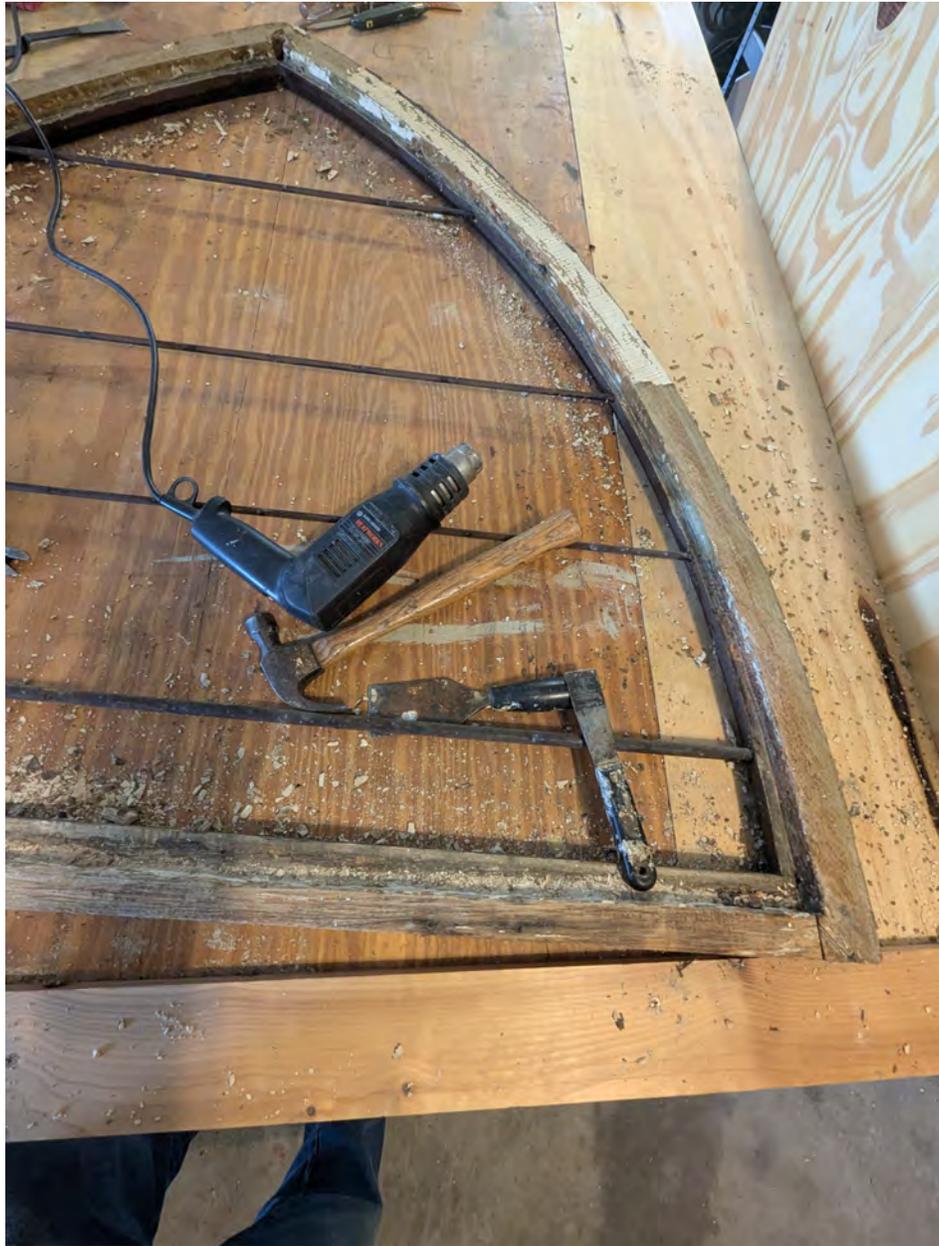
Figure 6: The frame was freed. See [12 Jul](#)

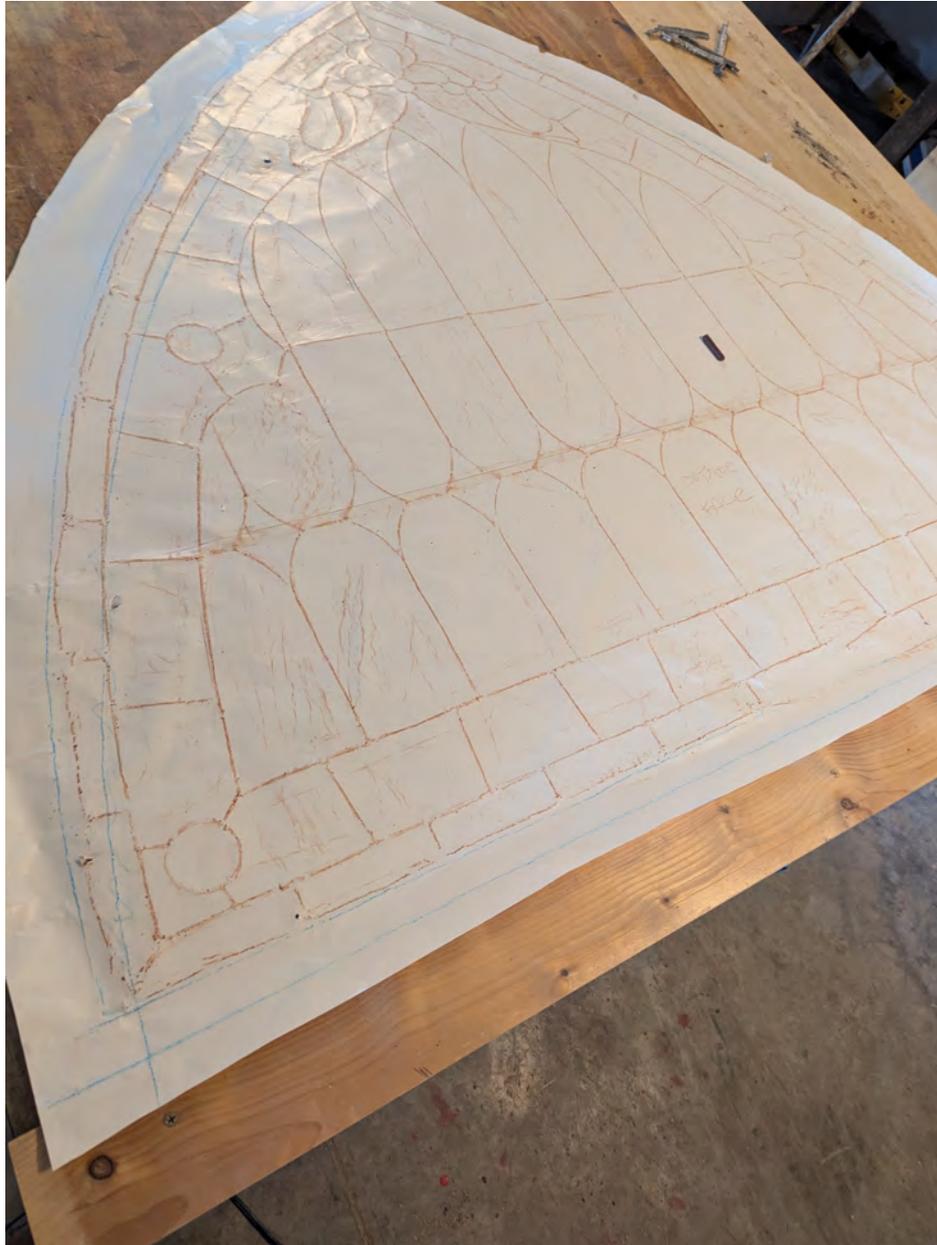
Figure 7: Laying the glass window on the work table, Don carefully made two rubbings of the lead lines with a crayon. One to build the window on, the other for laying out the pieces of glass in their correct place. See [17 Jul](#)

- 17 Jul Make rubbing of stained glass lead lines and interior shape of wood frame; begin to remove and separate the old lead from the glass; dismantle window; 7 hrs

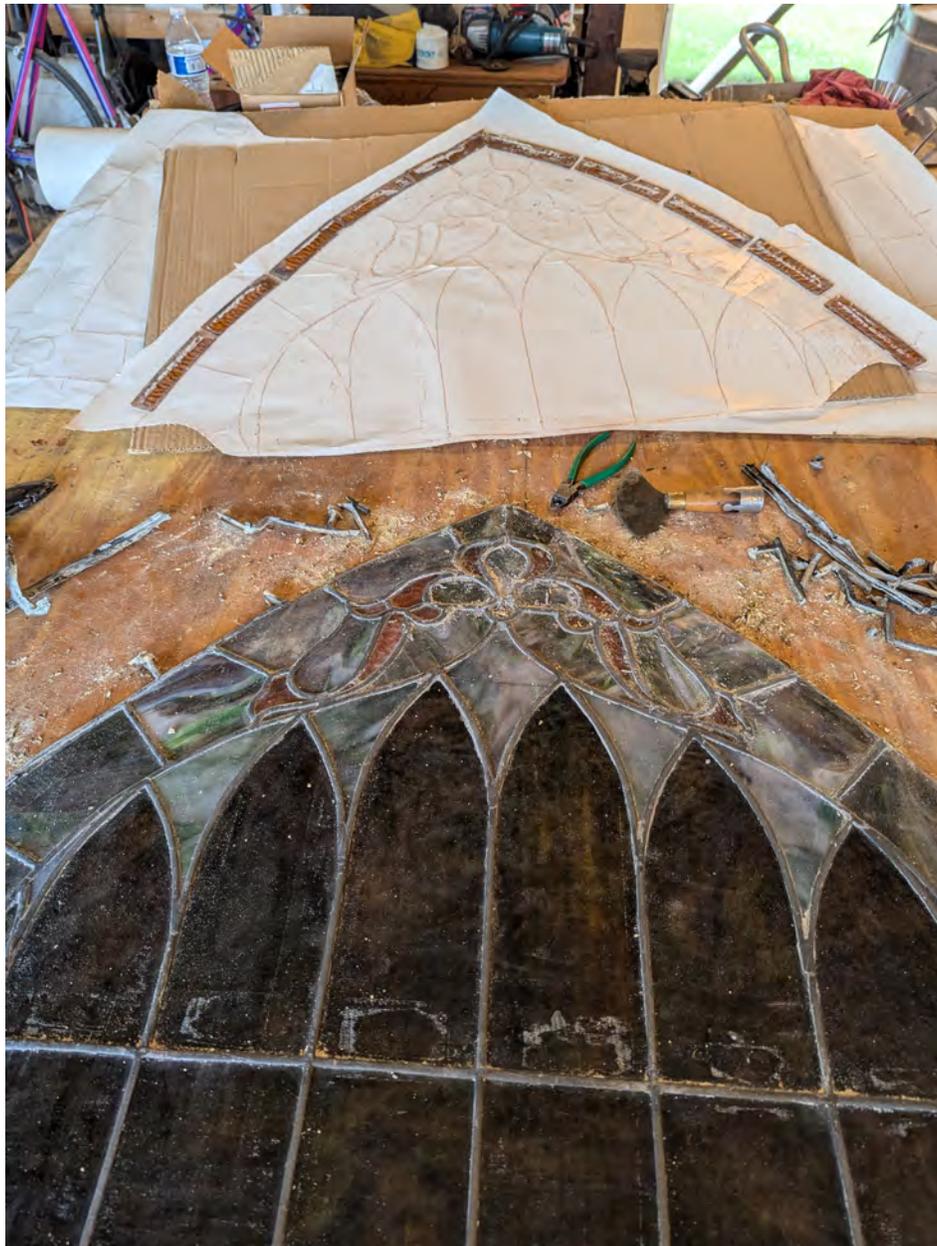
Figure 9: The glass is separated from the old brittle lead.

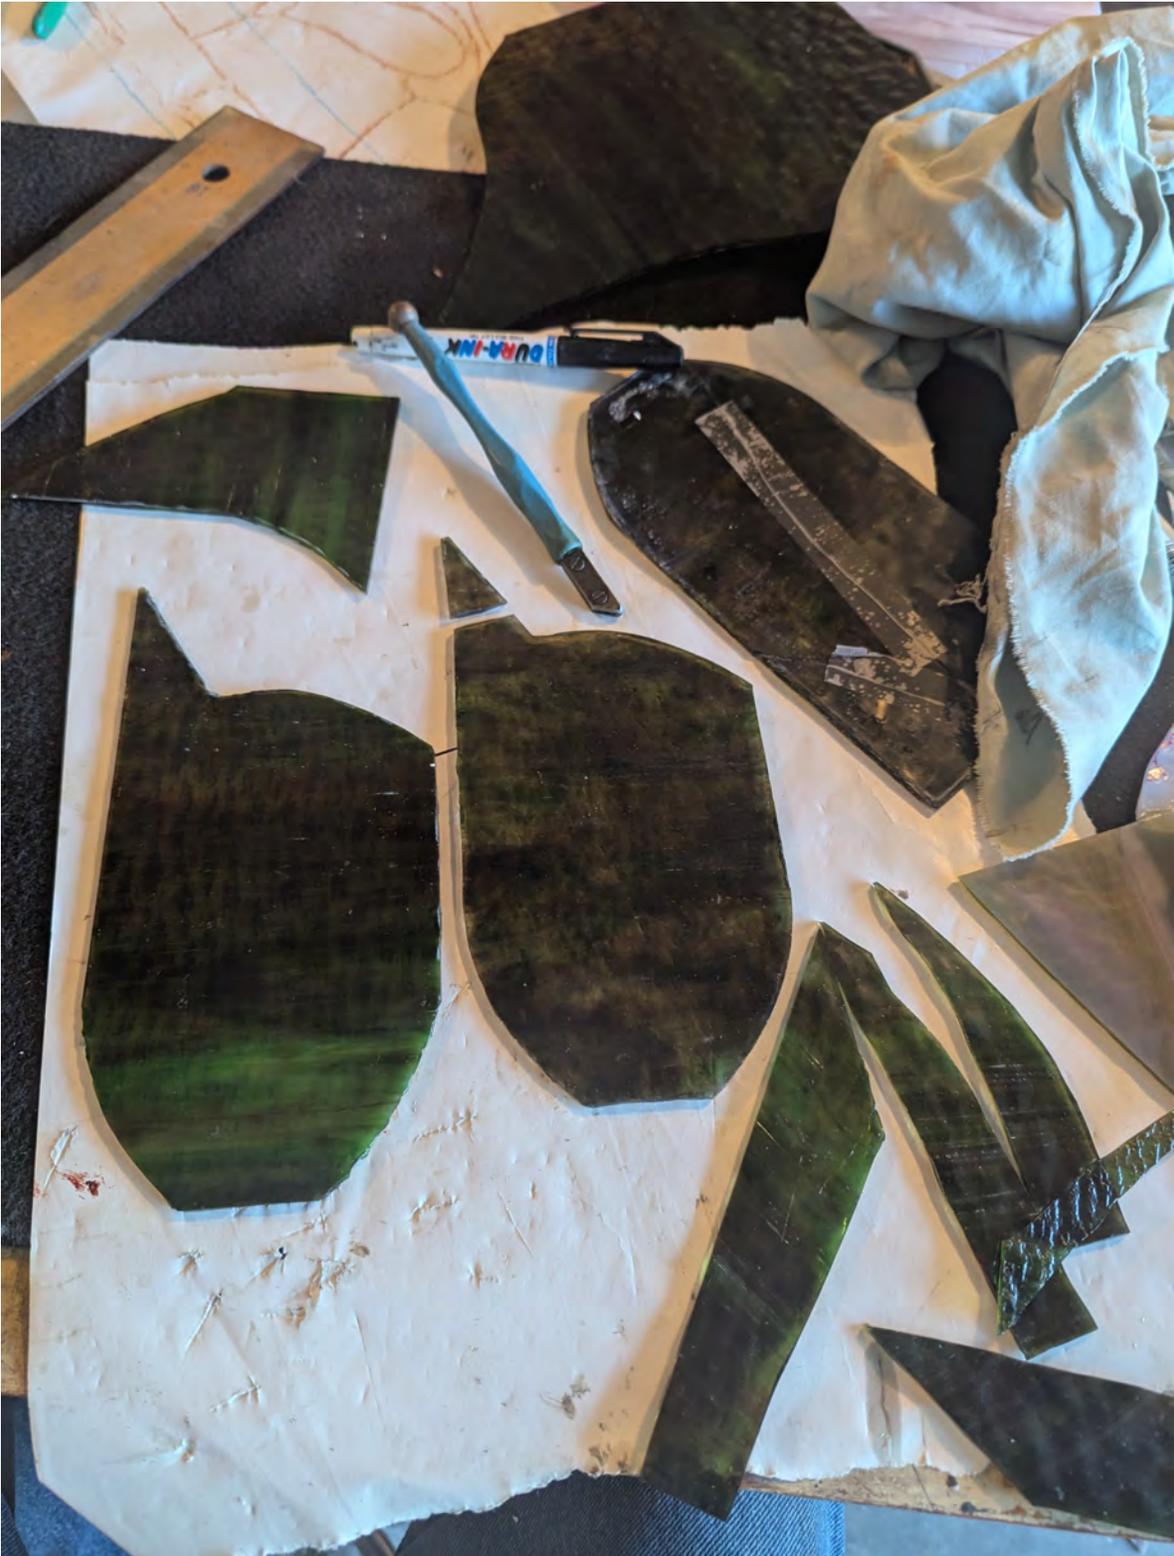
Figure 12: Twenty broken pieces were replaced with new glass.

- 18 Jul Drive to "The Vinery Glass" Whitewater WI for glass to match the 20 broken pieces and lead H cams for rebuilding window; 5 hrs
- 22 Jul Layout the rubbing of the window and square the centerline to the base of the glass; on another rubbing lay out the individual pieces of glass in their correct place; clean each piece of glass removing old cement, paint, and dirt; 3 hrs

- 23 Jul Cut new glass replacing the broken pieces; 5 hrs
- 24 Jul Start building the new window; 4 hrs
- 25 Jul Build window; 3 hrs
- 26 Jul Build window; miscellaneous cleanup; 2.5 hrs

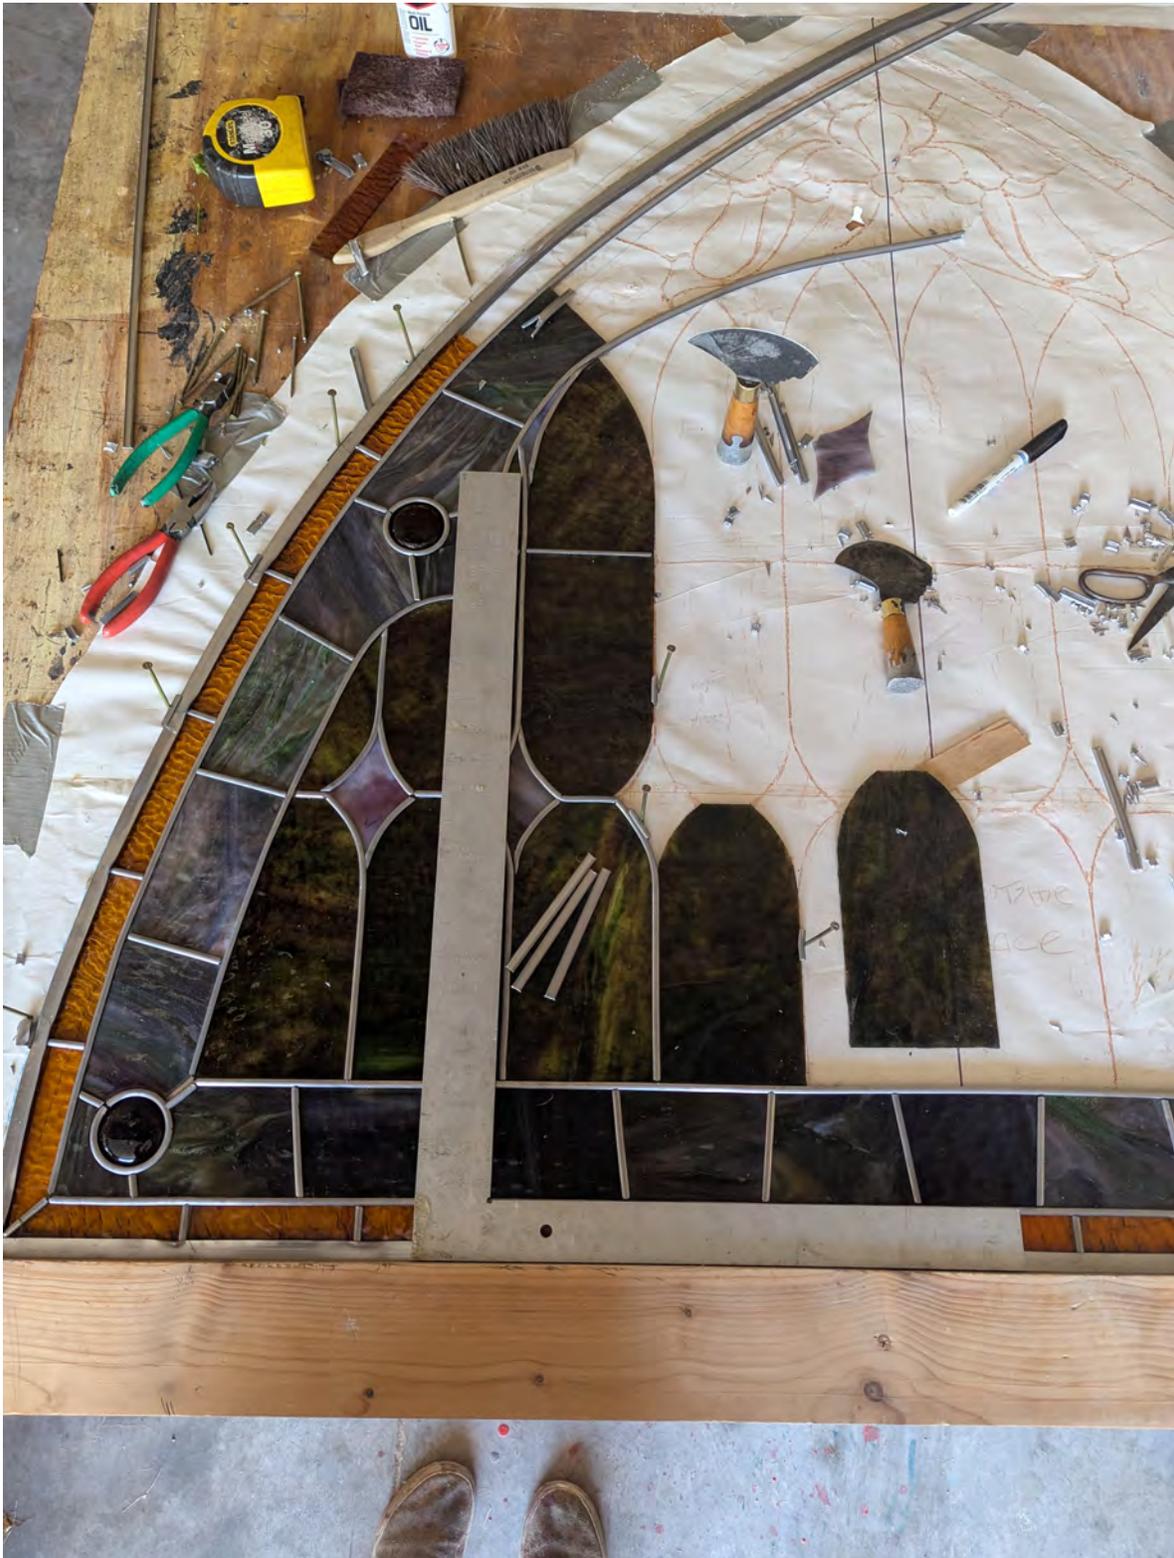
Figure 14: The window is built out from the lower left corner, making sure the vertical lines of the $\frac{3}{16}$ " lead comes and window are square. With nails holding the glass in place. See [24 Jul](#)

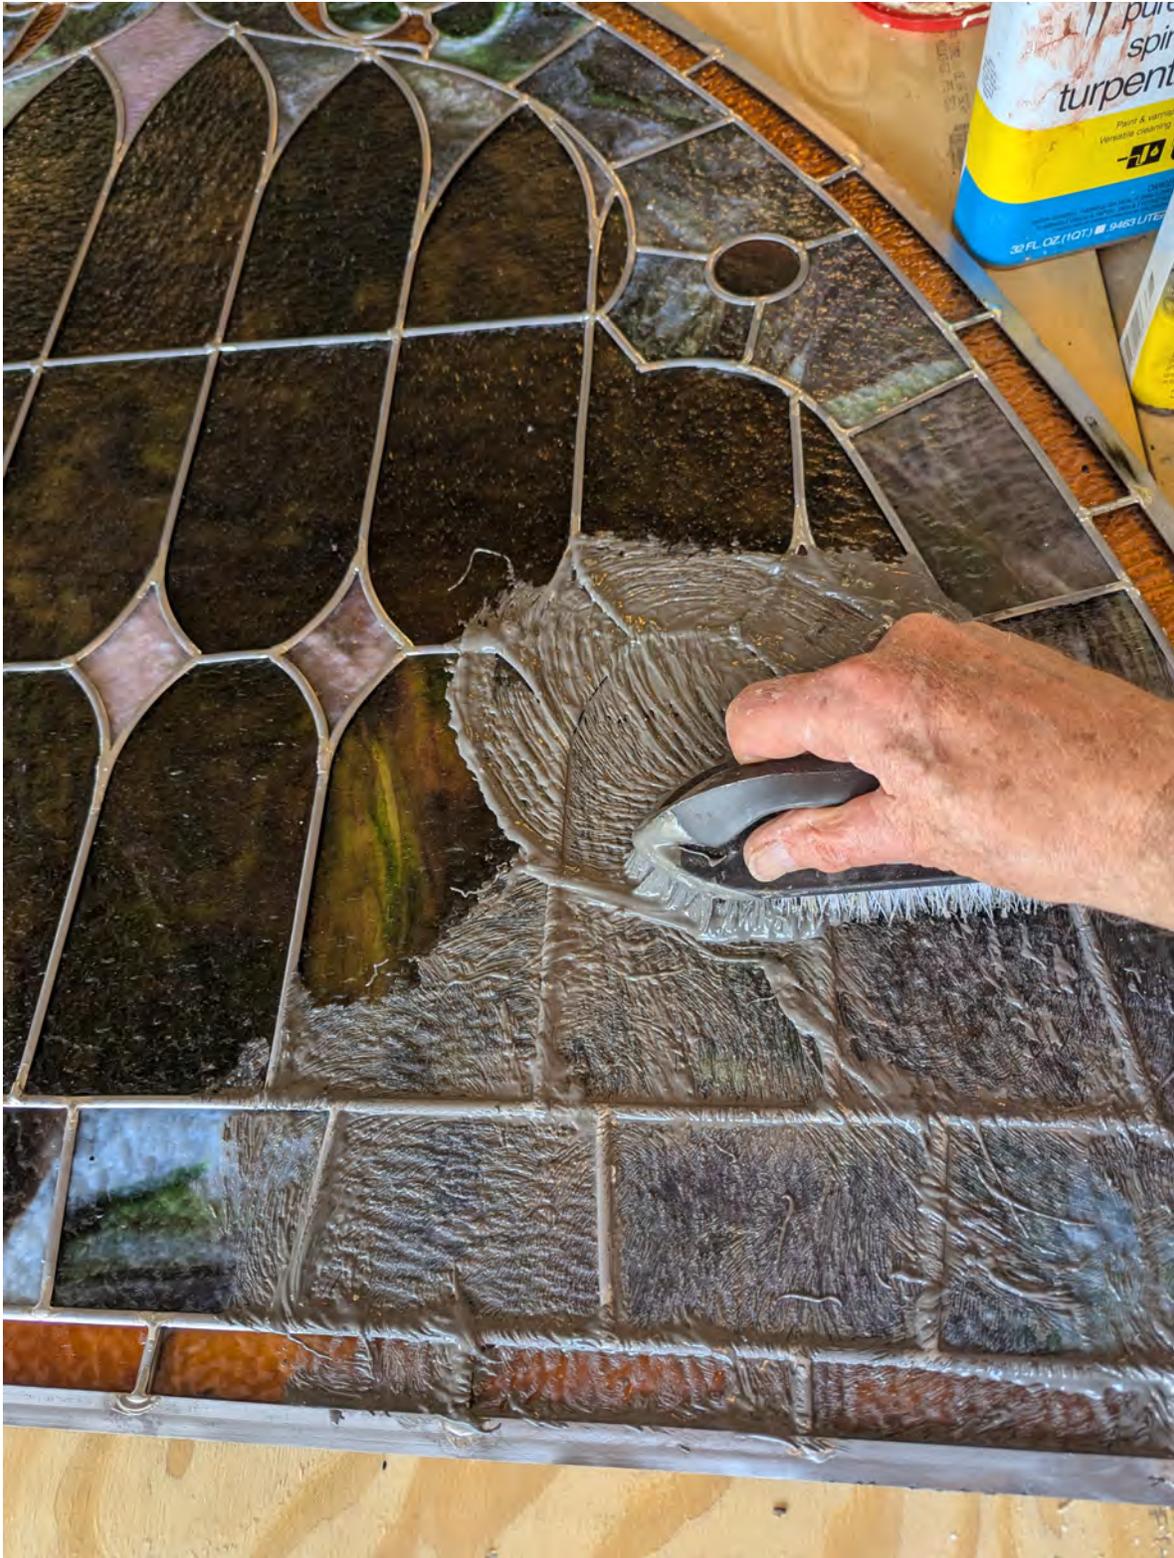
Figure 18: After the window is built, a cement made of putty, turpentine, linseed oil, Japan drier, plaster, and some black oil paint (or lamp black) for a gray color. In the old days, a generous amount of lead oxide was added. This cement is scrubbed into the lead to form a seal between the lead and the glass. The excess being removed with a stiff brush.

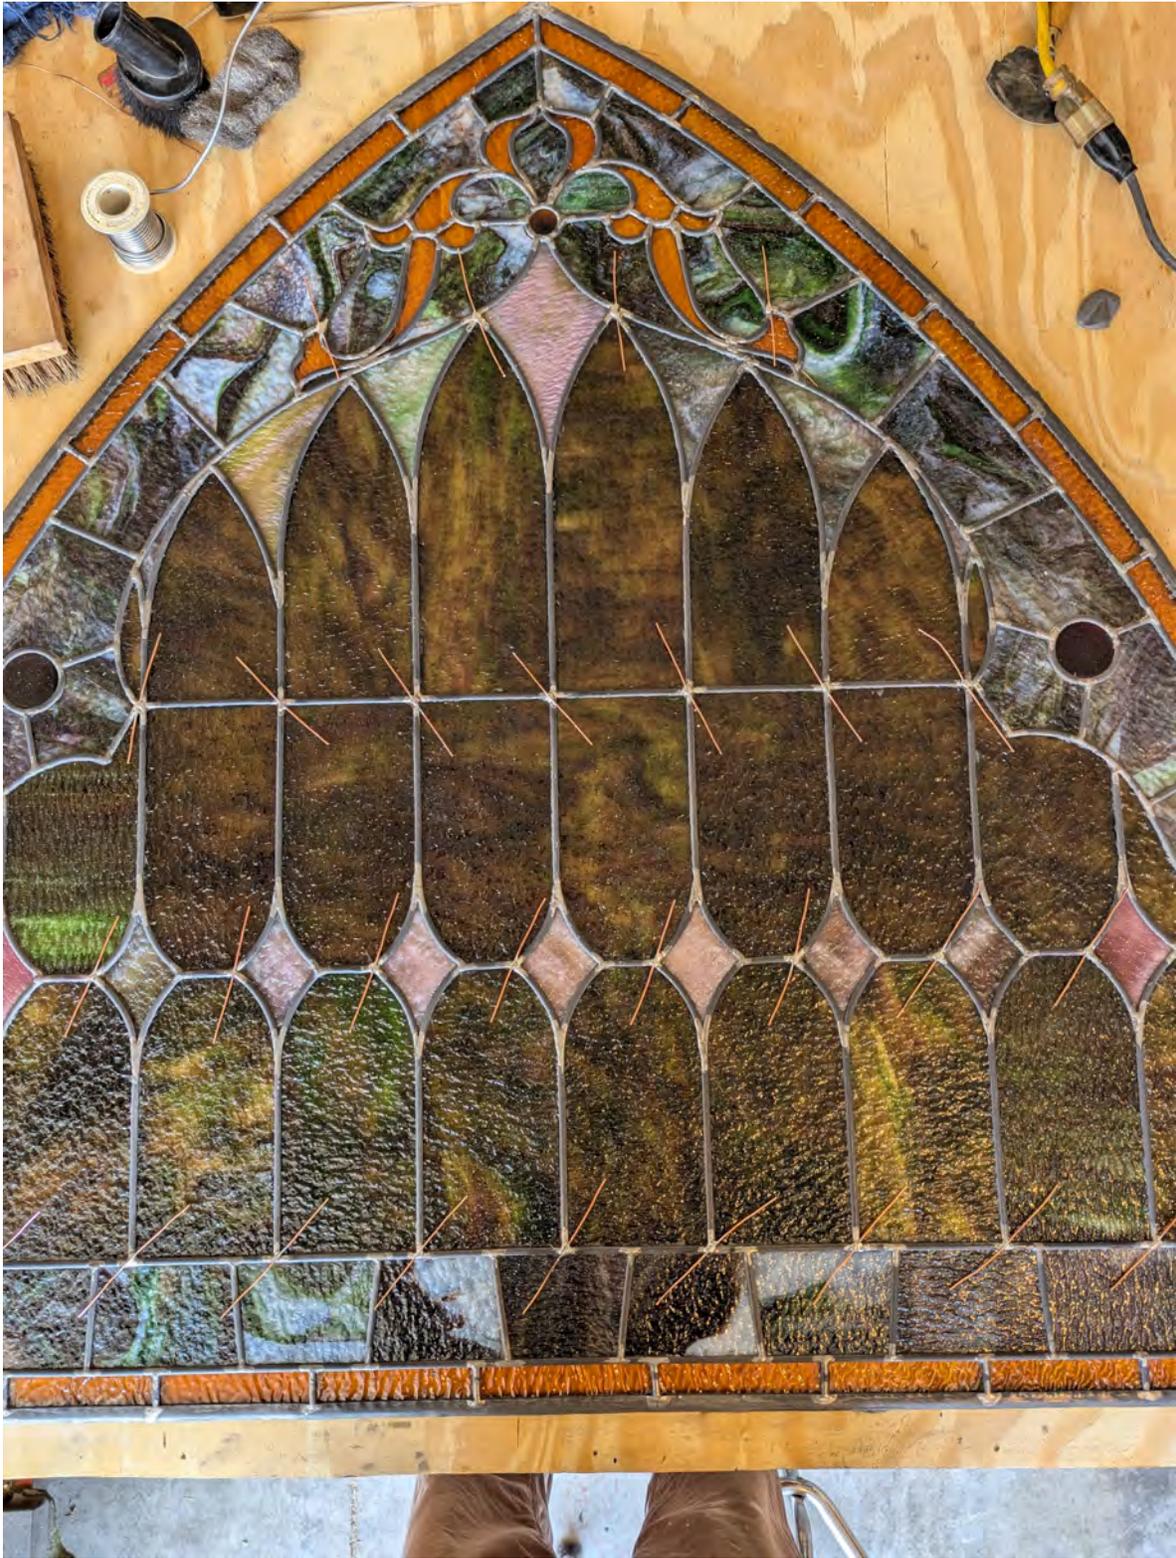
Figure 22: Copper wires were replaced and soldered.

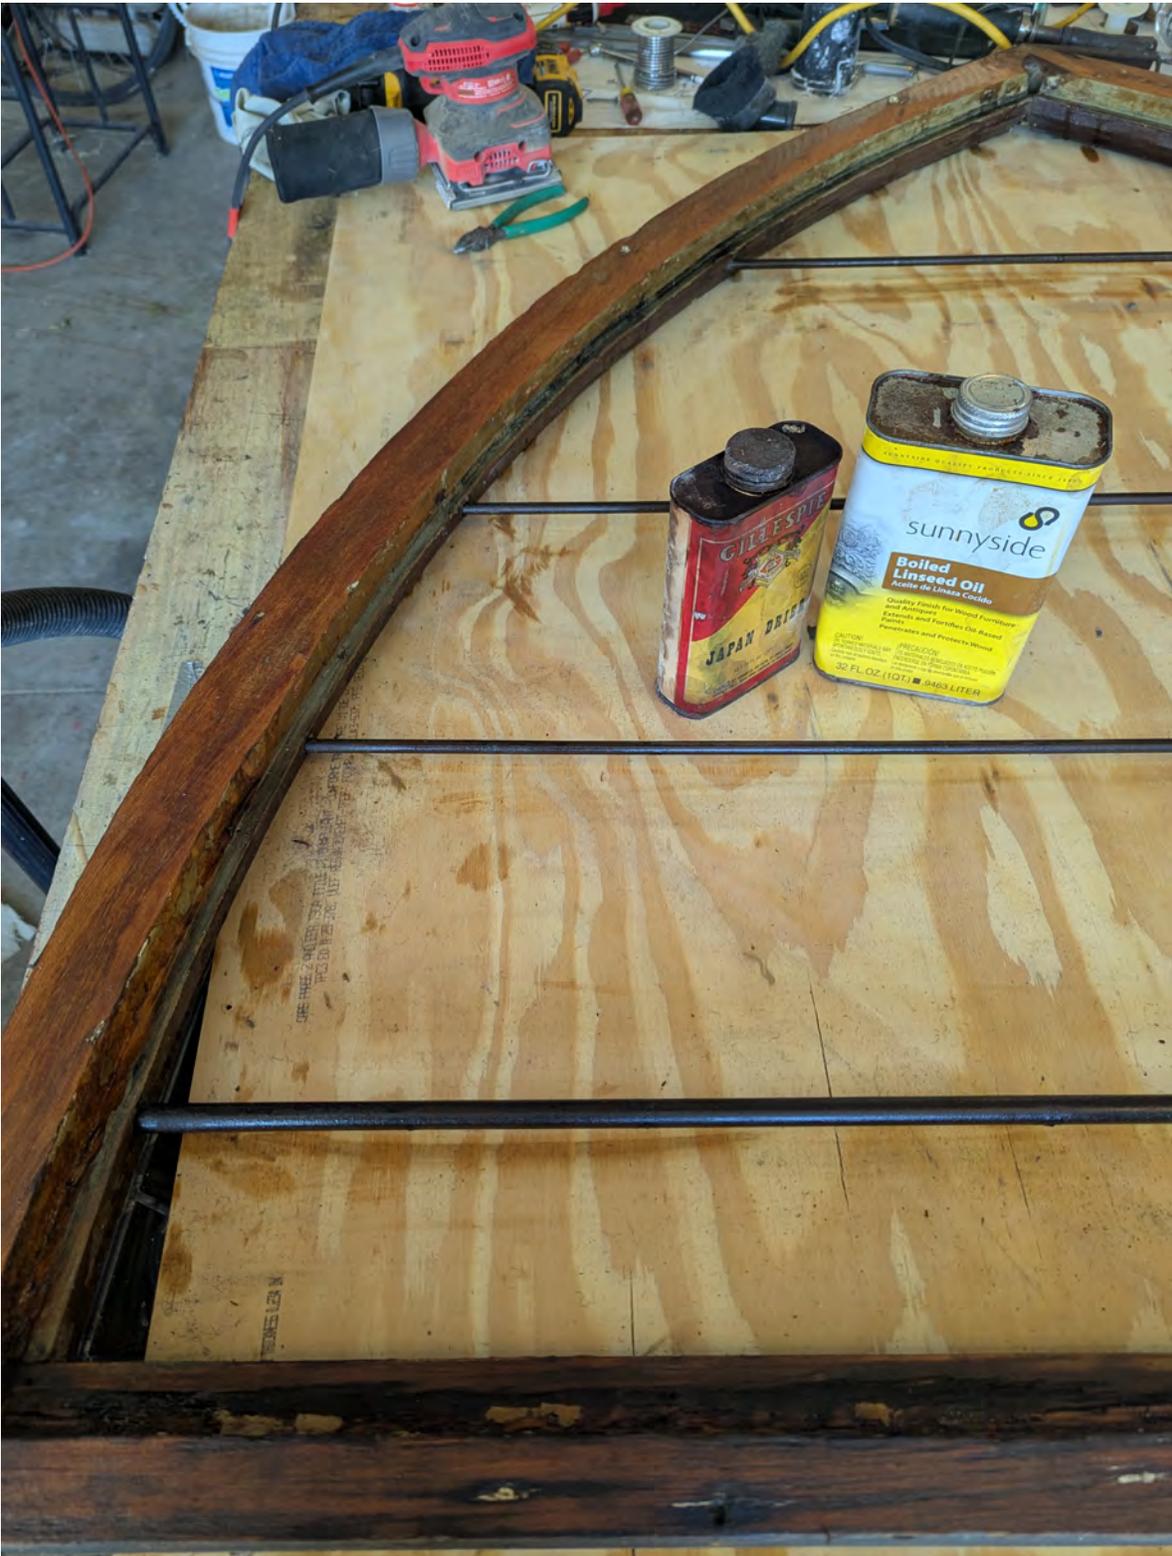
Figure 24: The wood frame turned out to be in excellent condition. It was enough to treat it with linseed oil and paint.

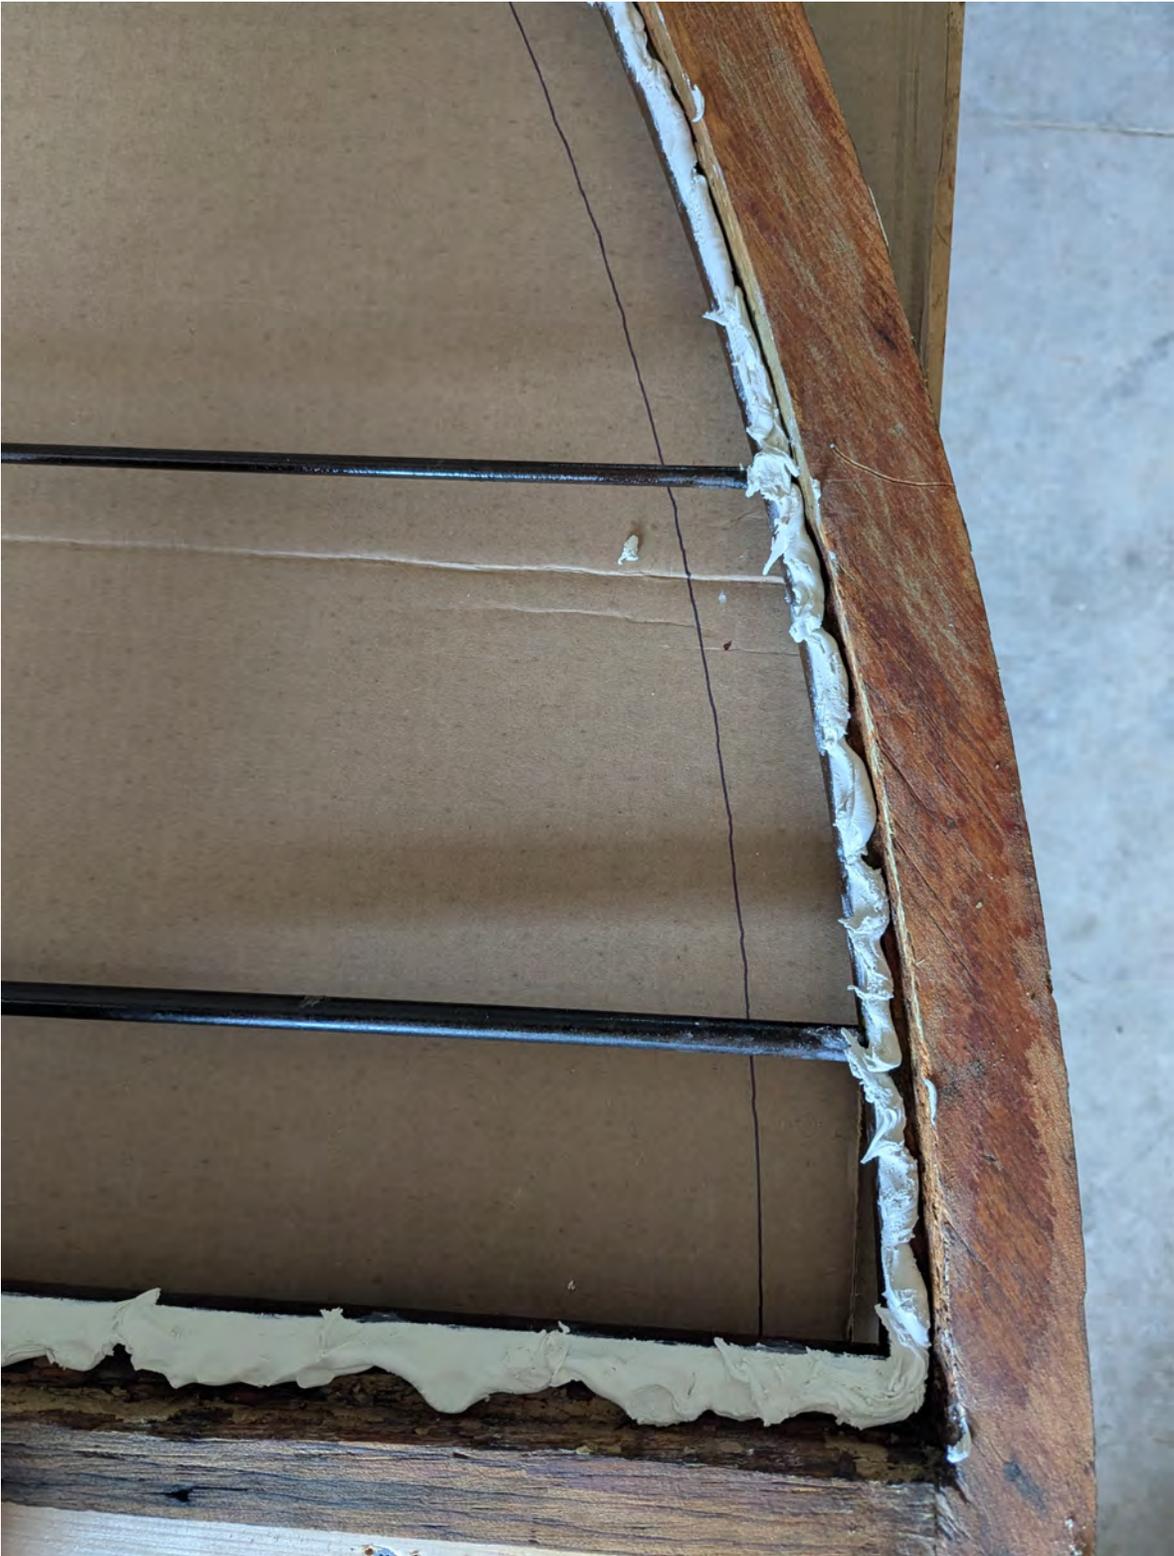
Figure 26: Putty is applied to the frame and the new window is pressed into the putty.

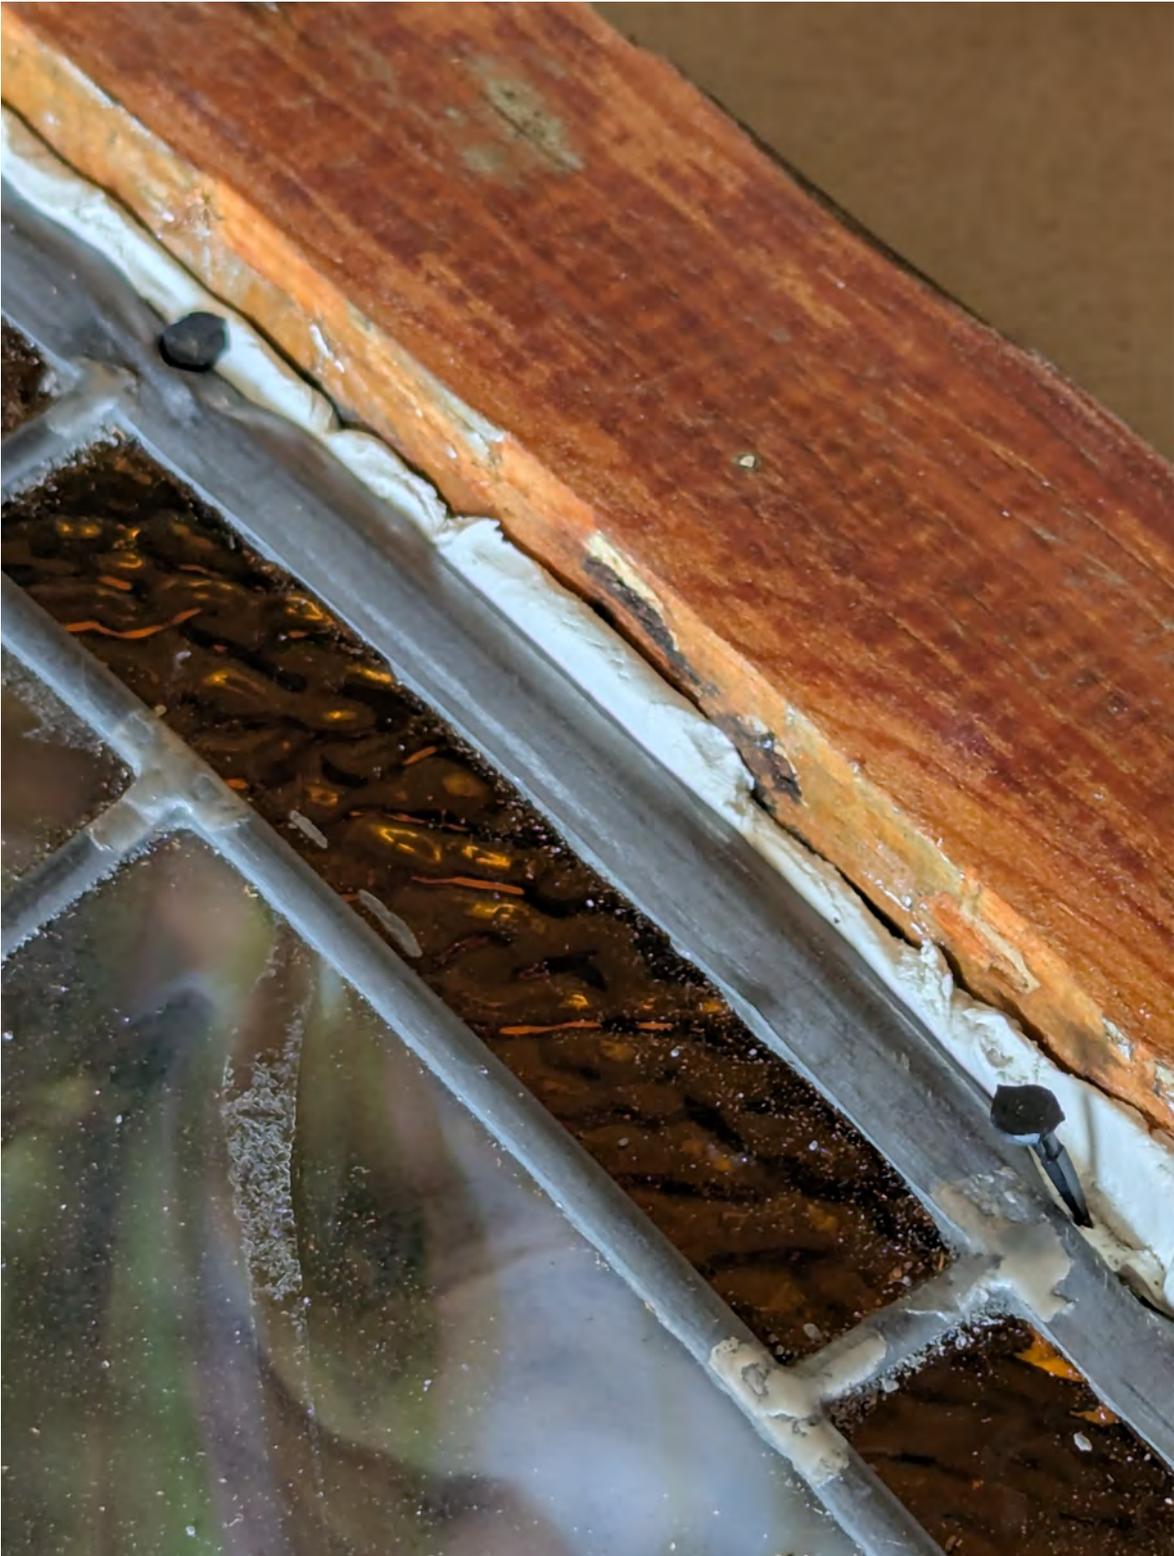
Figure 27: The glass is secured with carpet tacks around the window.
