Revival of a Stained-Glass Window

Don Pellett
as told to: Sergei Smirenski

January 15, 2026

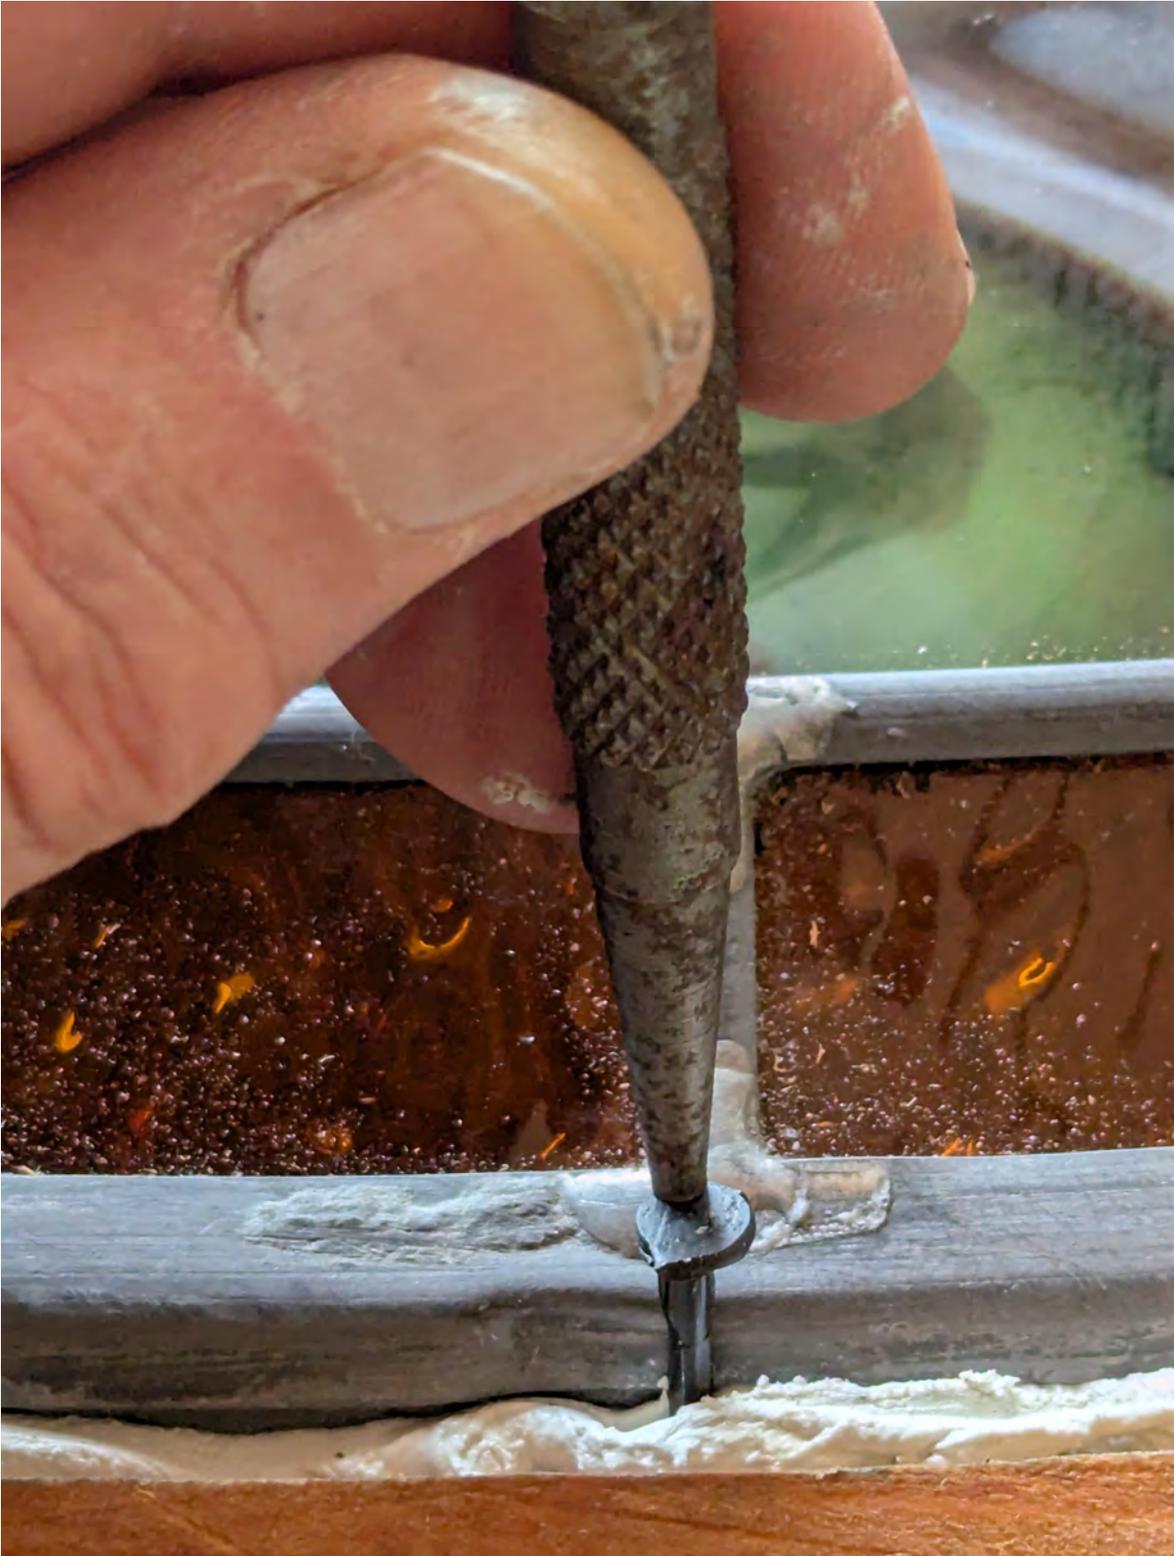
Figure 28: Putty was applied to the frame and the new window was pressed into the putty and then secured with carpet tacks around the window followed by the final application of putty. The new copper wires were then secured to the rebars on the interior of the frame.

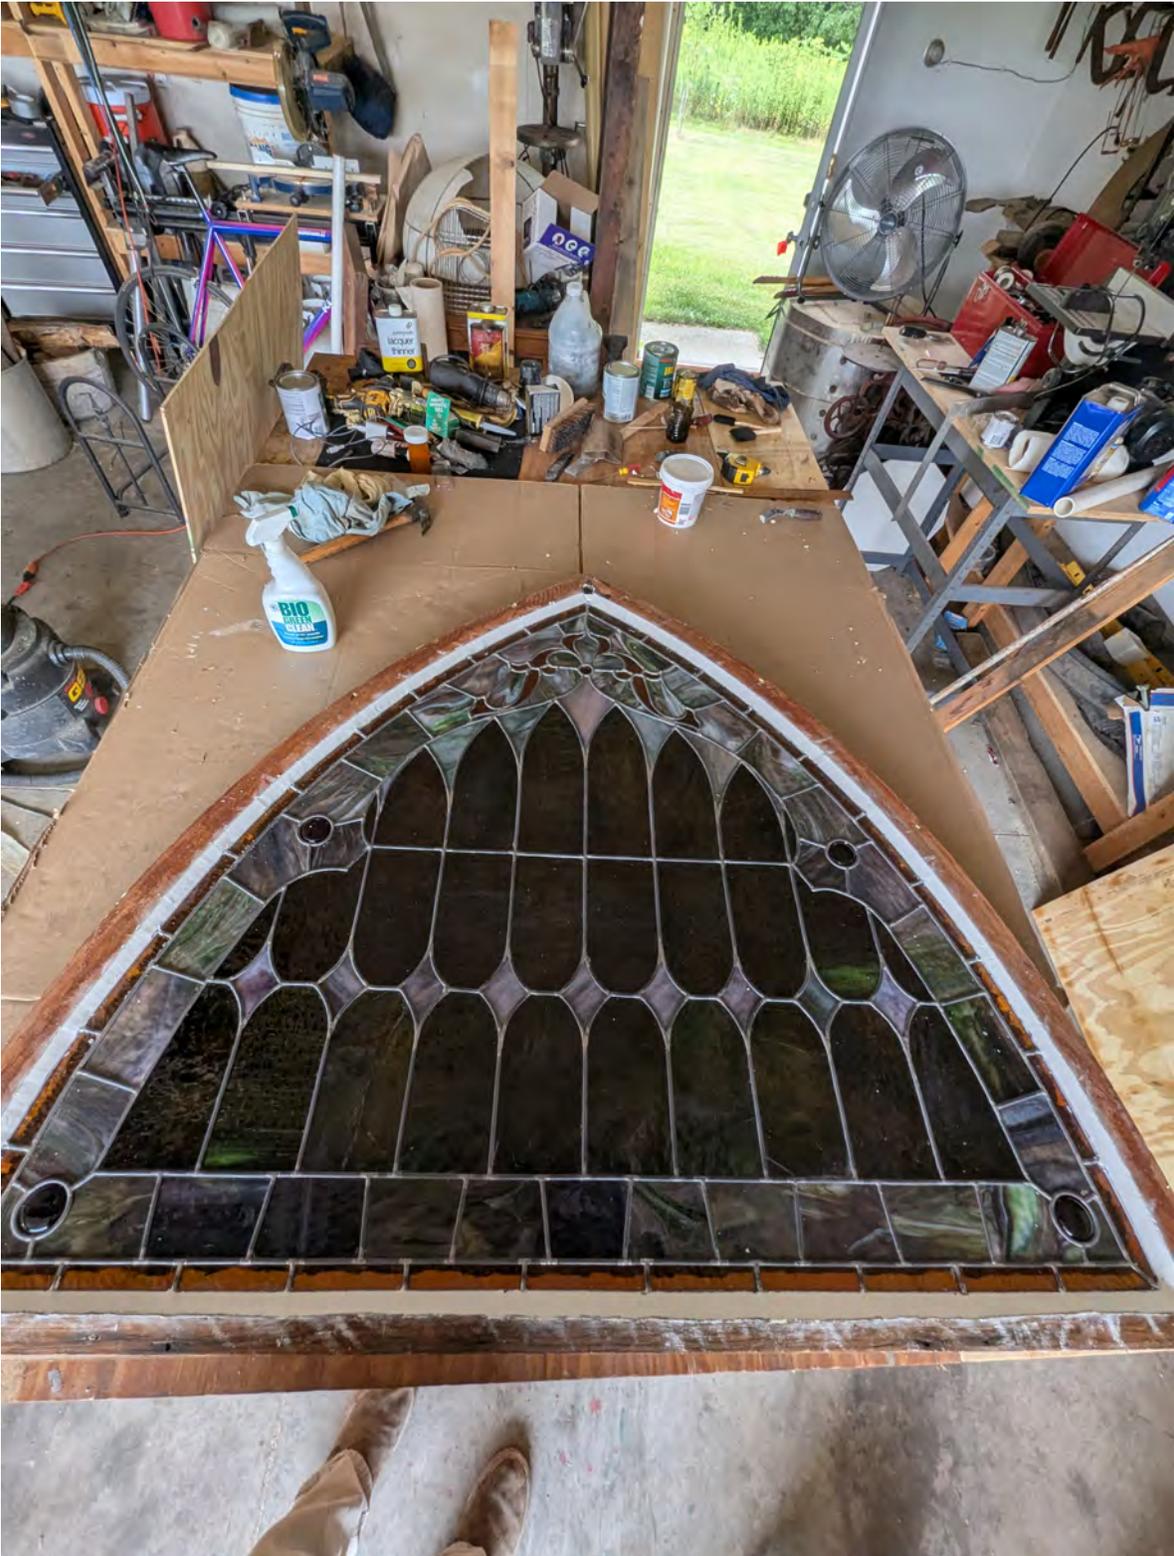
Figure 29: A final application of putty is applied.

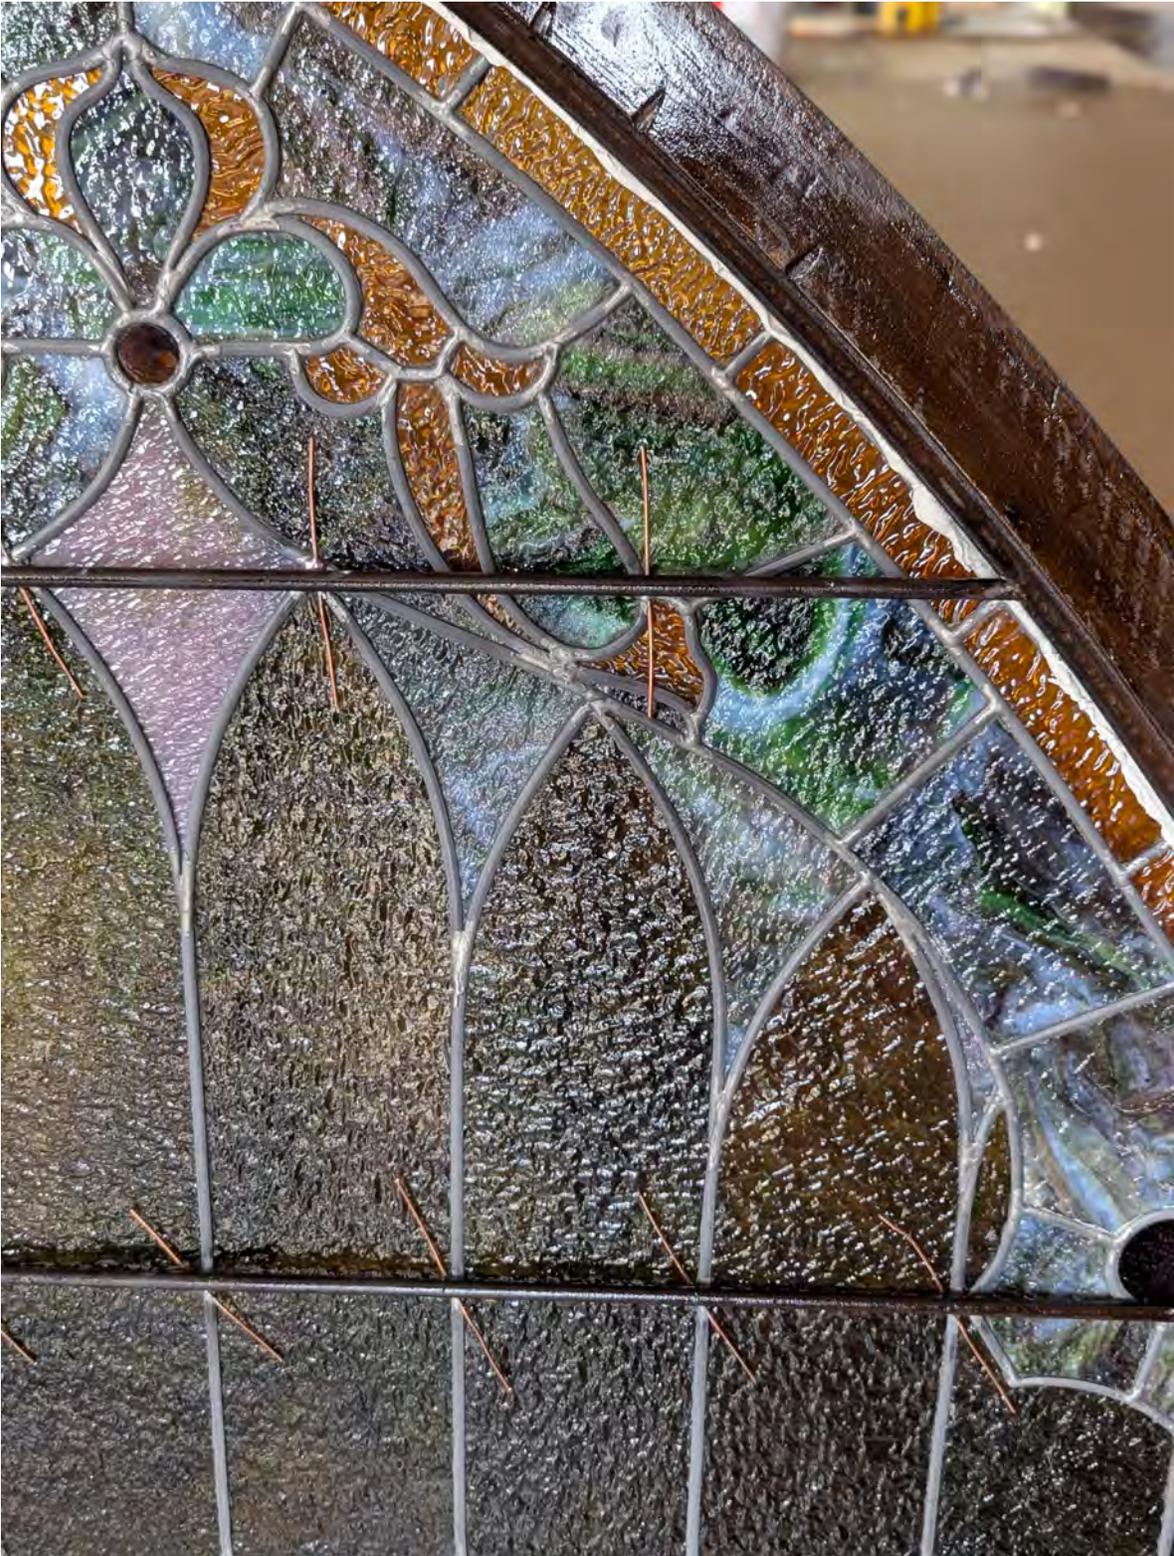
Figure 30: The new copper wires were then secured to the rebars.

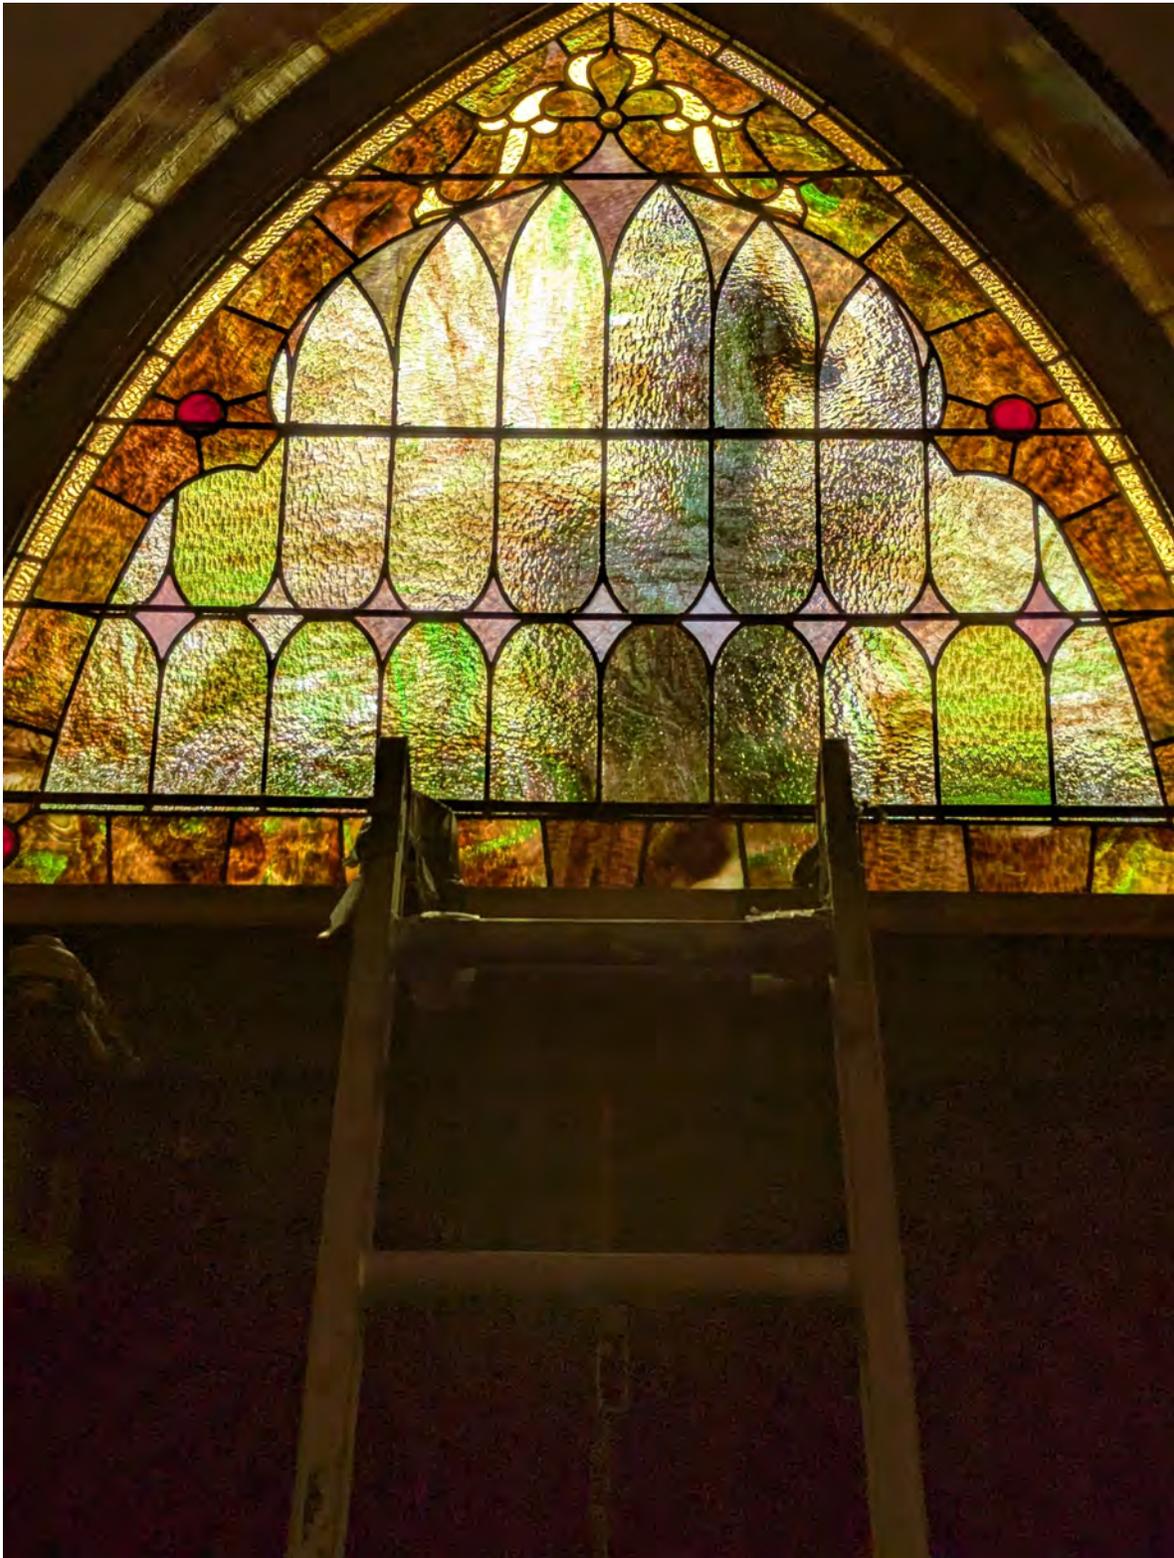
Figure 35: A sheet of Lexan was cut to fit covering and protecting the glass and on September 6, 2025 by the Grace of God colorful and joyful light once again is shining this window for the second century.

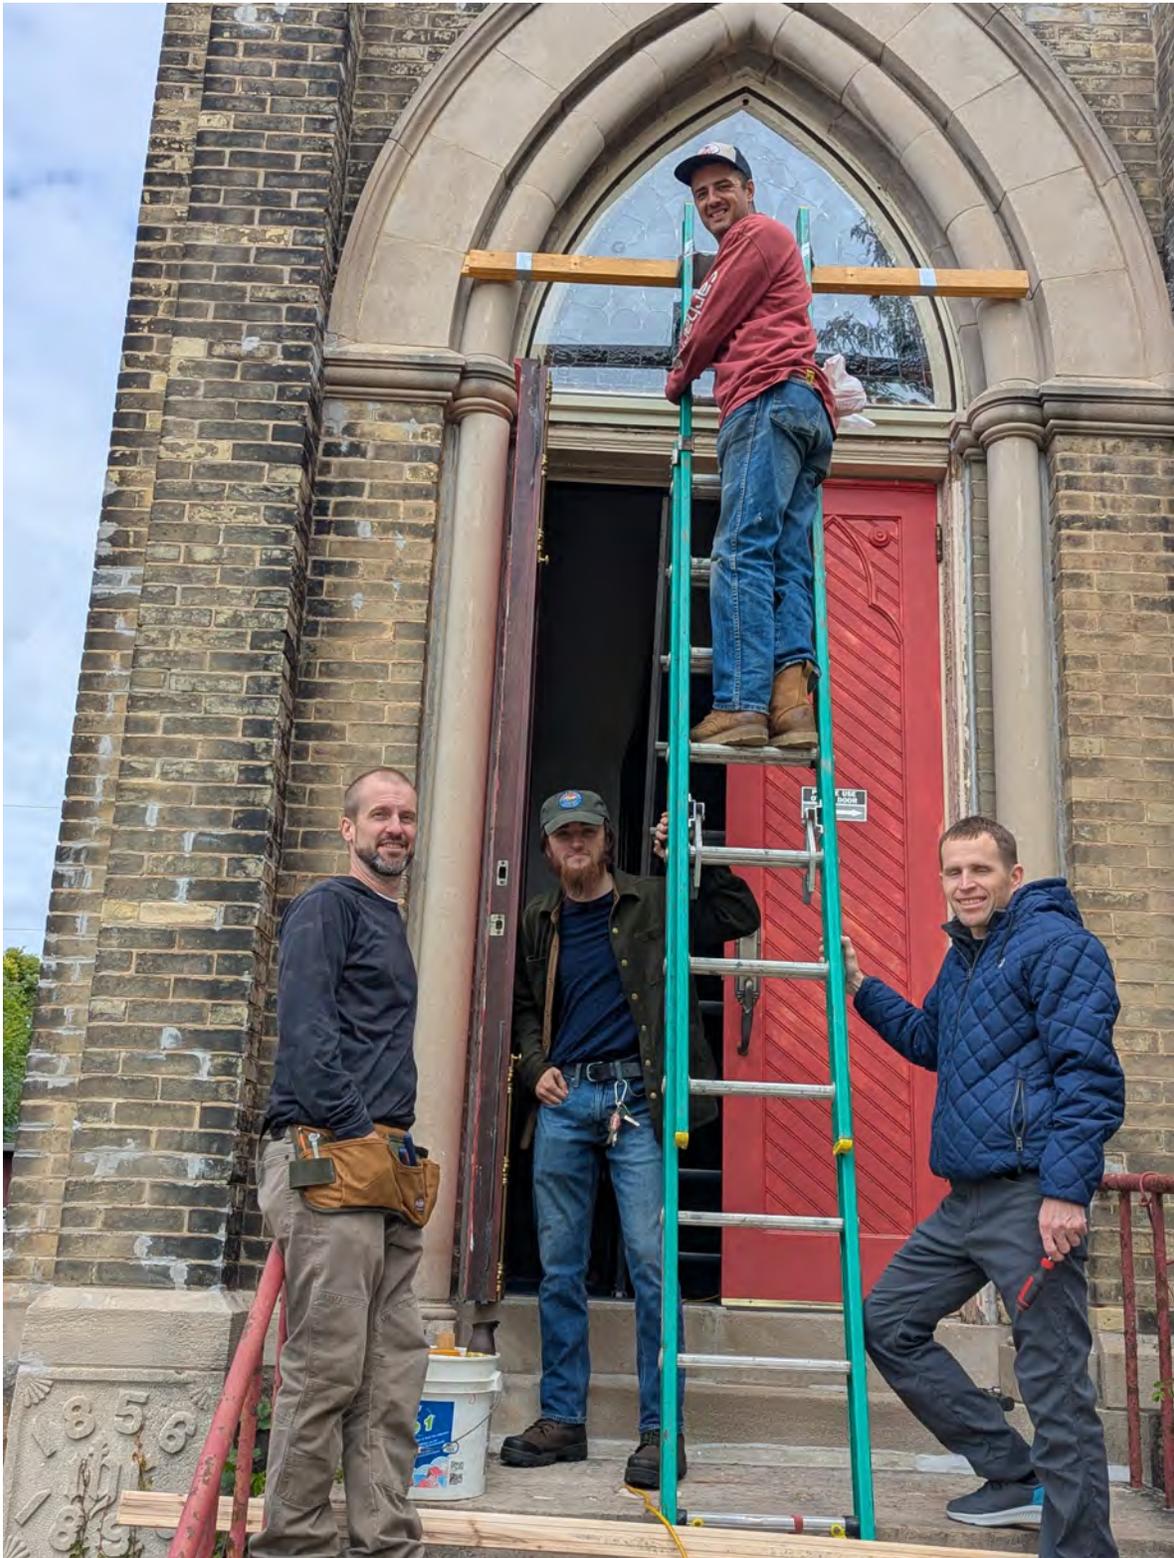
Figure 36: Parishioners: Erik Hefner, Fr Dcn Matthew Swiggum, Clay Zierk, and Evgheni Ilovan carefully lifted and re-installed fragile stained-glass piece. See [06 Sep](#)

- 06 Aug Remove old varnish from inside of wood frame and make pattern for cutting Lexan; 2 hrs
- 07 Aug Cut copper wires and solder them to window for attaching the rebars; 2 hrs
- 08 Aug Back putty the frame, install glass in frame over putty; press in and hammer carpet tacks at every lead joint around the leaded window; attach the copper wires around the rebars; 5 hrs
- 14 Aug Paint outer side of frame with 1-2-3 primer; putty window; paint finish coat of exterior paint; 4 hrs
- 02 Sep Pickup Lexan, 1/2" U-channel, spray paint, stainless steel screws, and foam tape; 4 hrs
- 03 Sep Cut Lexan, spray paint U-channel, pre-drill holes for screws, make 56" wood sill, cut notches in U-channel to bend to shape and fit; drill 1" hole at top of Lexan for exterior light fixture; 5 hrs
- 06 Sep Install window and Lexan protection glazing; 5 hrs [Figure 36](#)
