Revival of a Stained-Glass Window

Don Pellett
as told to: Sergei Smirenski

January 15, 2026

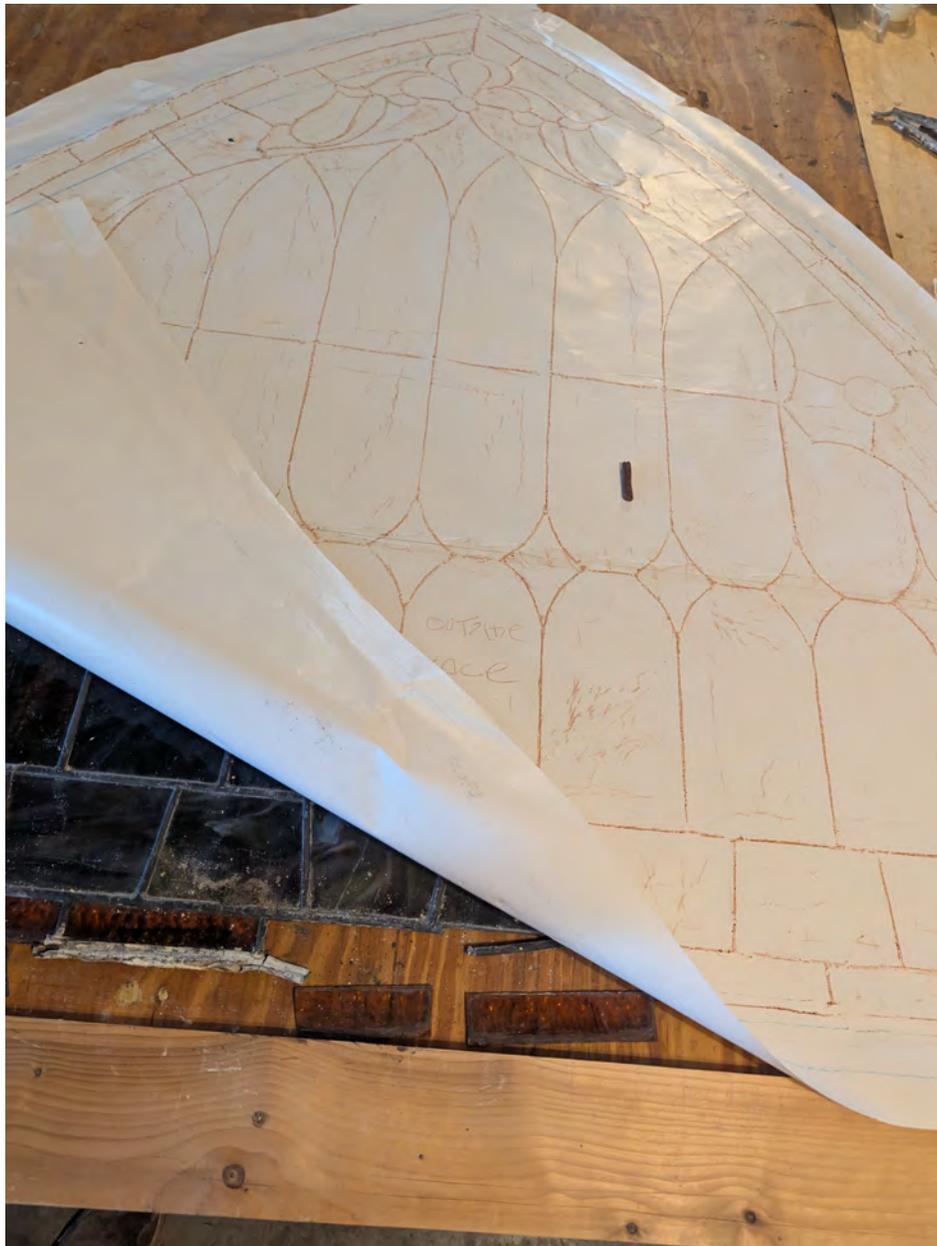
Figure 7: Laying the glass window on the work table, Don carefully made two rubbings of the lead lines with a crayon. One to build the window on, the other for laying out the pieces of glass in their correct place. See [17 Jul](#)

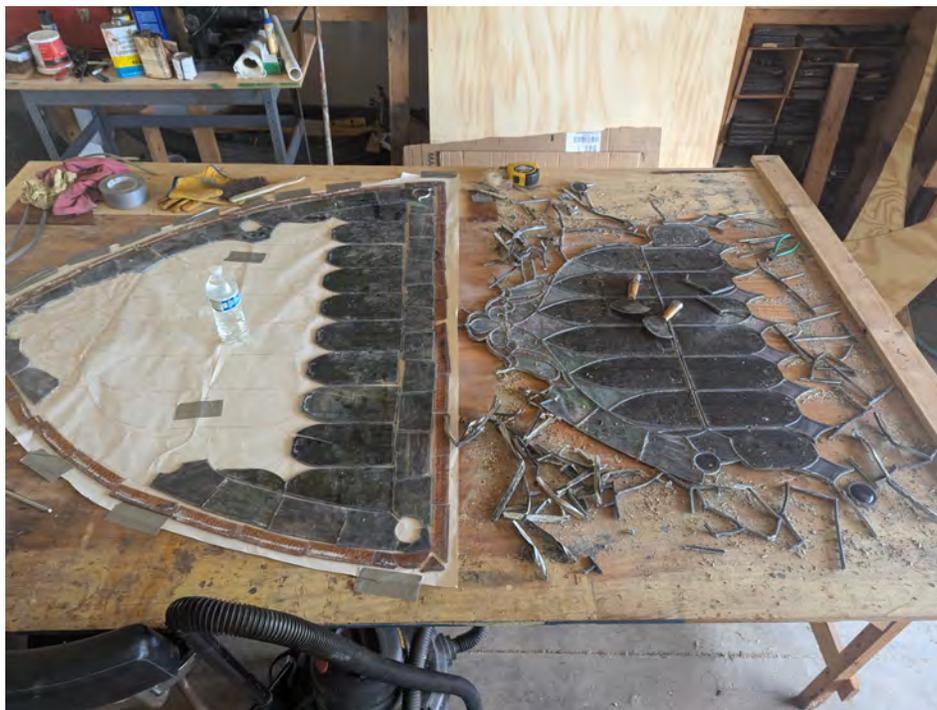
Figure 9: The glass is separated from the old brittle lead.

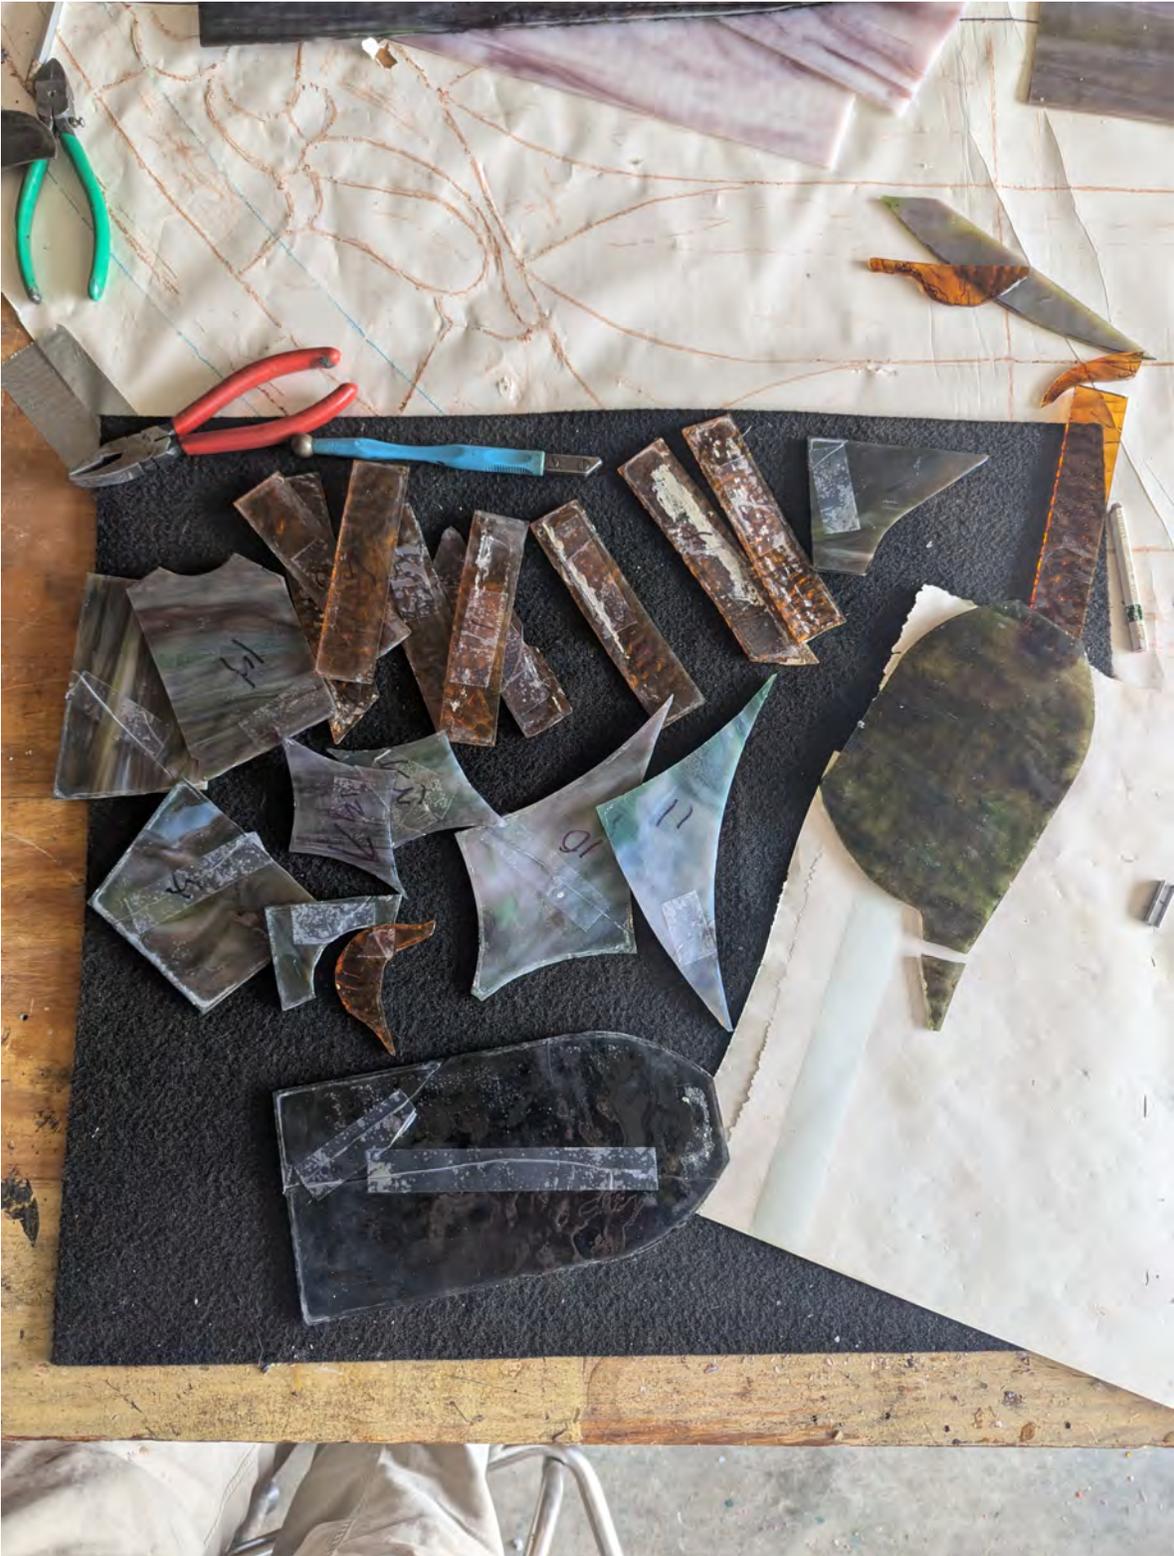
Figure 12: Twenty broken pieces were replaced with new glass.

- 18 Jul Drive to "The Vinery Glass" Whitewater WI for glass to match the 20 broken pieces and lead H cams for rebuilding window; 5 hrs
- 22 Jul Layout the rubbing of the window and square the centerline to the base of the glass; on another rubbing lay out the individual pieces of glass in their correct place; clean each piece of glass removing old cement, paint, and dirt; 3 hrs

- 23 Jul Cut new glass replacing the broken pieces; 5 hrs
- 24 Jul Start building the new window; 4 hrs
- 25 Jul Build window; 3 hrs
- 26 Jul Build window; miscellaneous cleanup; 2.5 hrs

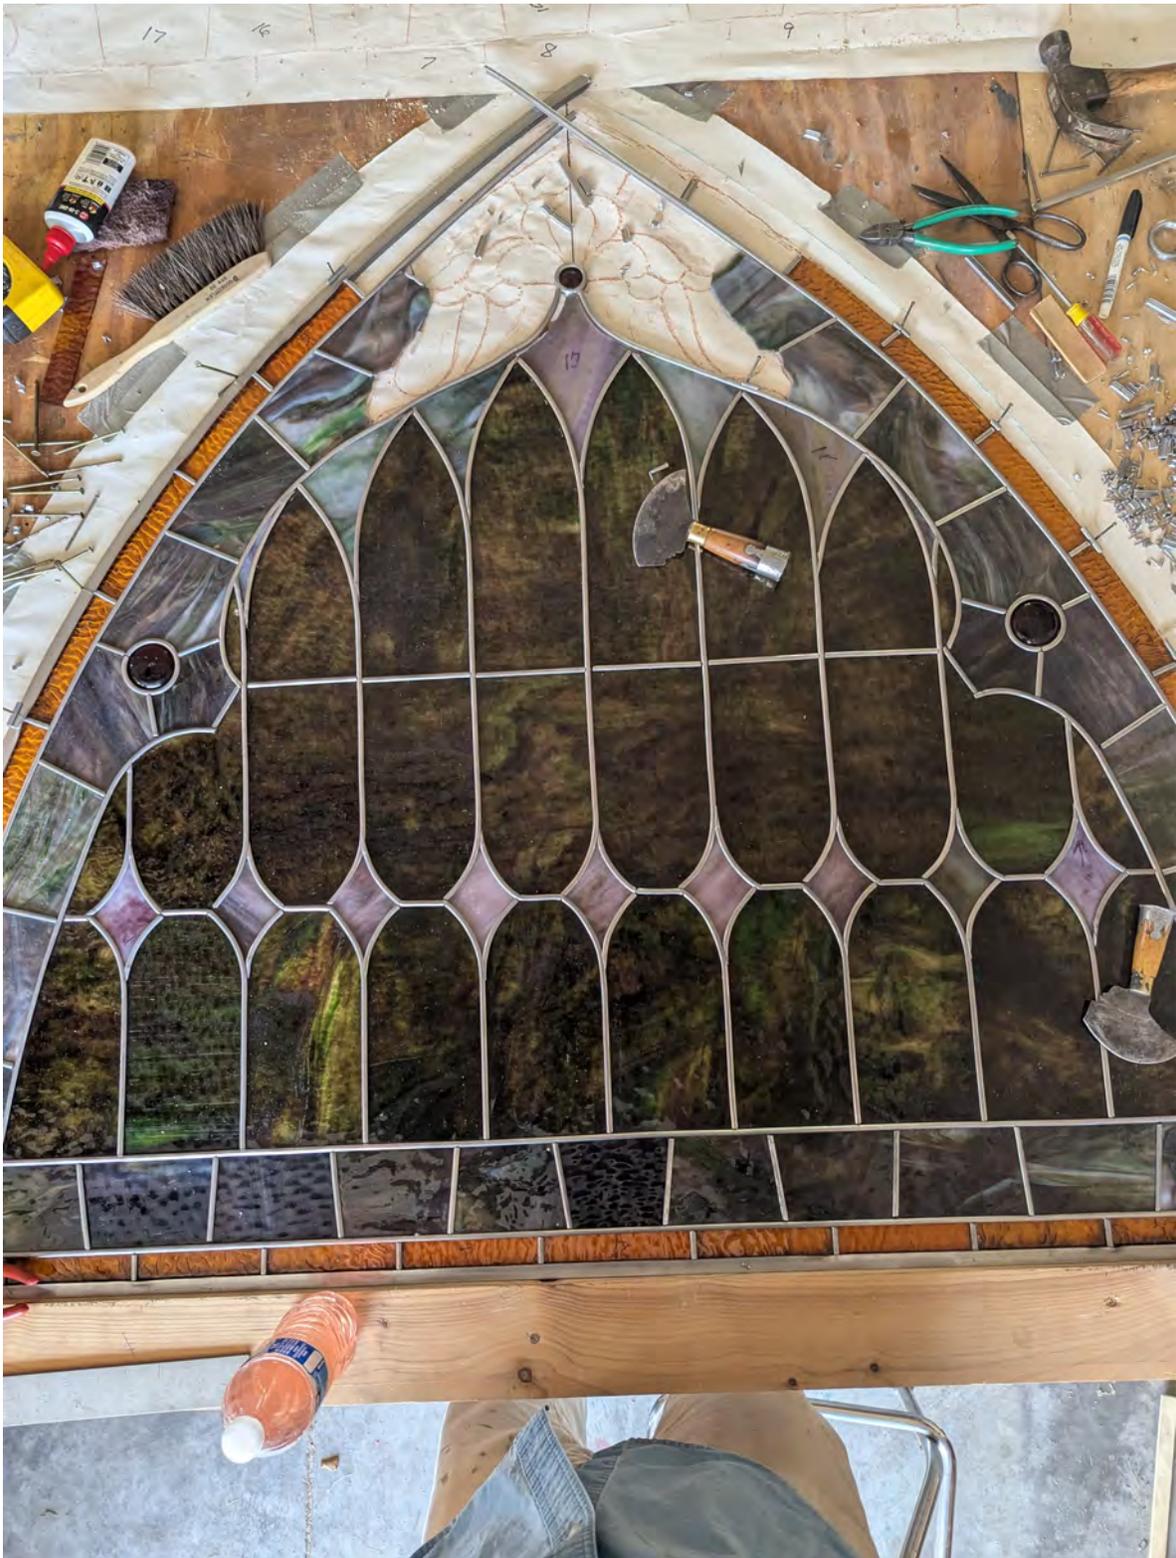
Figure 14: The window is built out from the lower left corner, making sure the vertical lines of the $\frac{3}{16}$ " lead comes and window are square. With nails holding the glass in place. See [24 Jul](#)

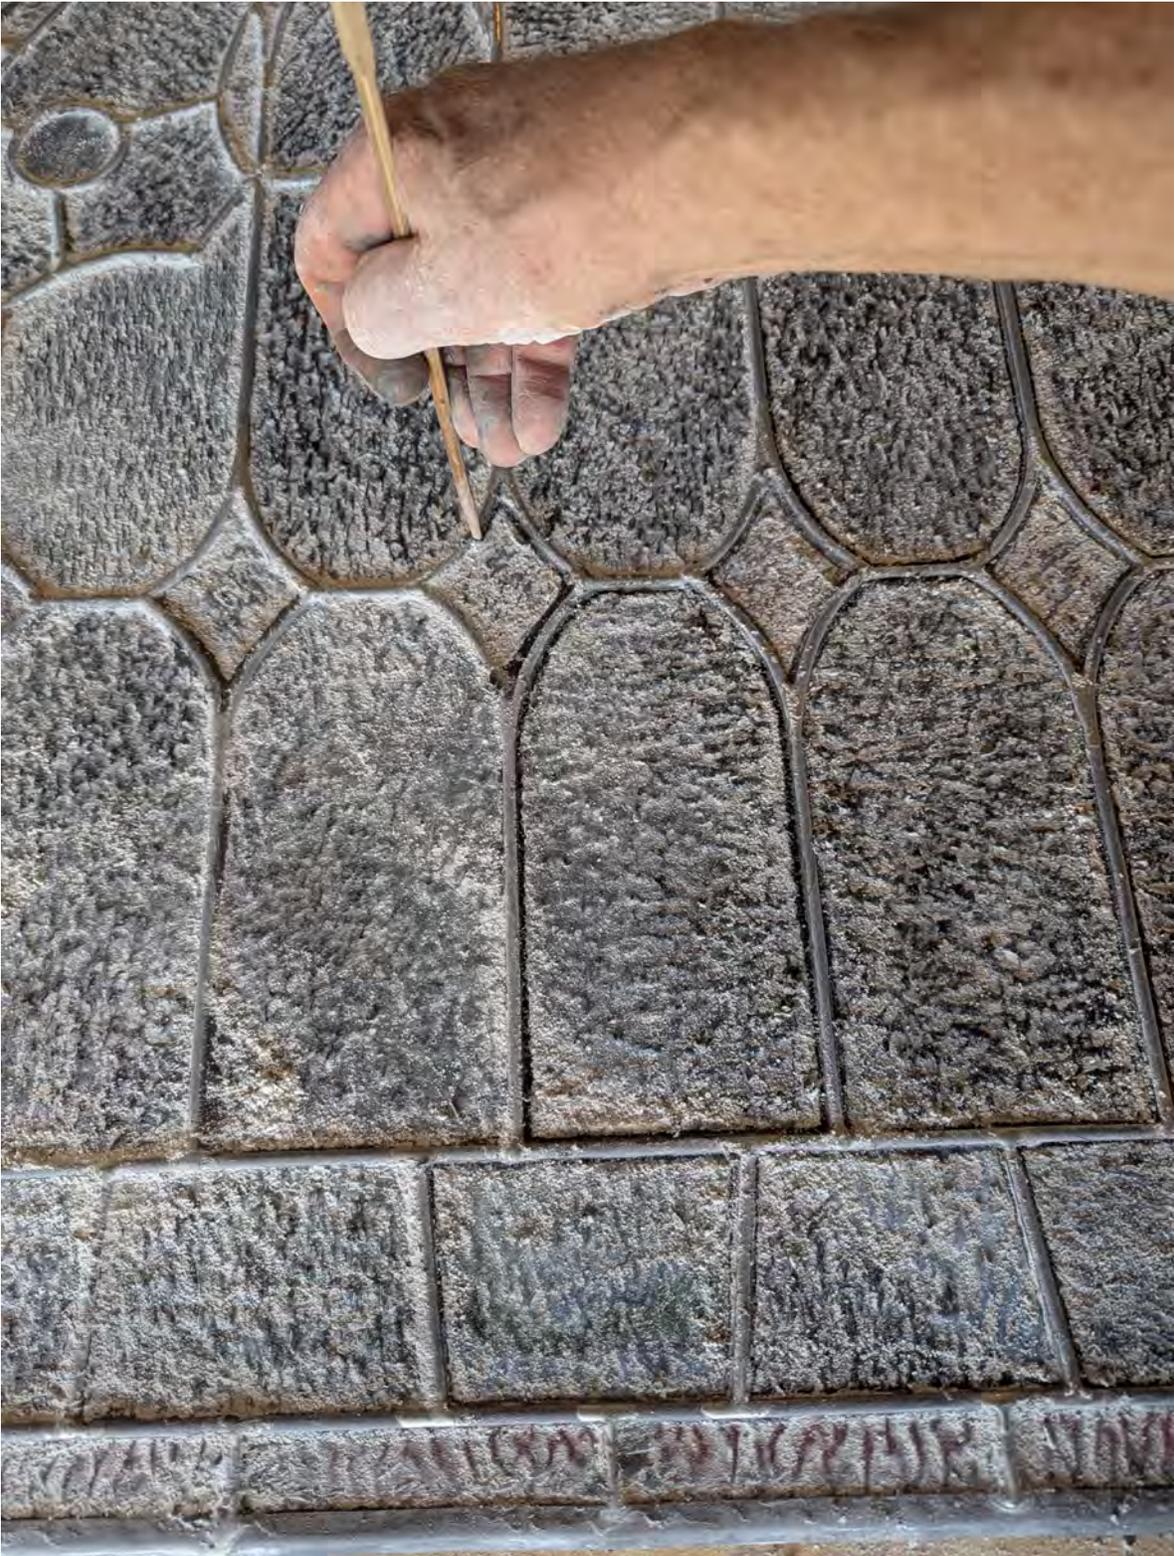
Figure 18: After the window is built, a cement made of putty, turpentine, linseed oil, Japan drier, plaster, and some black oil paint (or lamp black) for a gray color. In the old days, a generous amount of lead oxide was added. This cement is scrubbed into the lead to form a seal between the lead and the glass. The excess being removed with a stiff brush.

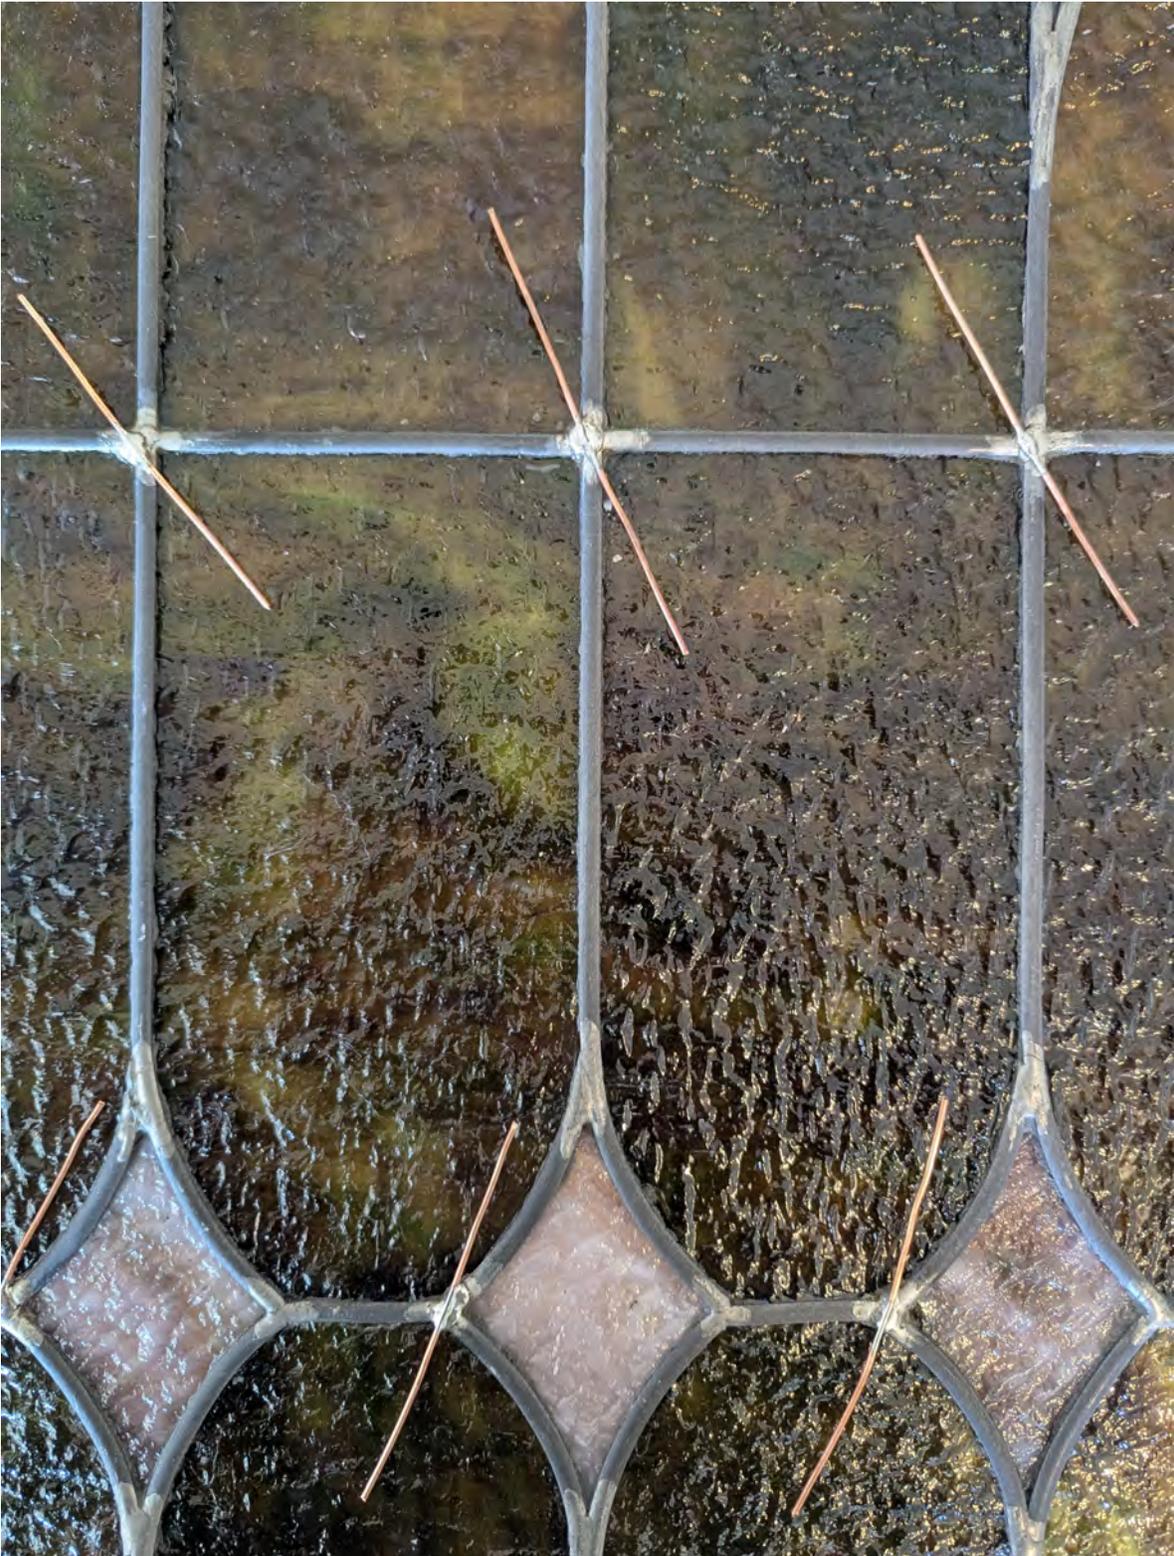
Figure 22: Copper wires were replaced and soldered.

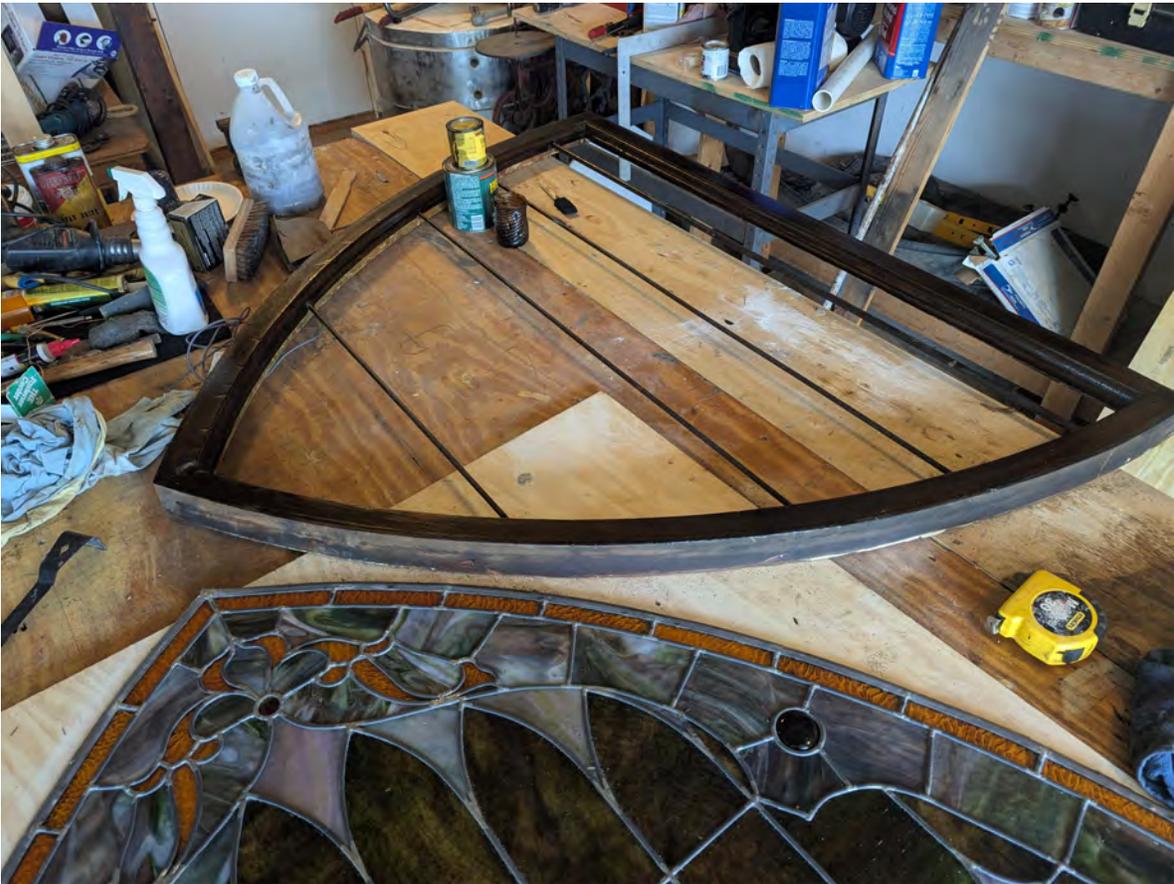
Figure 24: The wood frame turned out to be in excellent condition. It was enough to treat it with linseed oil and paint.

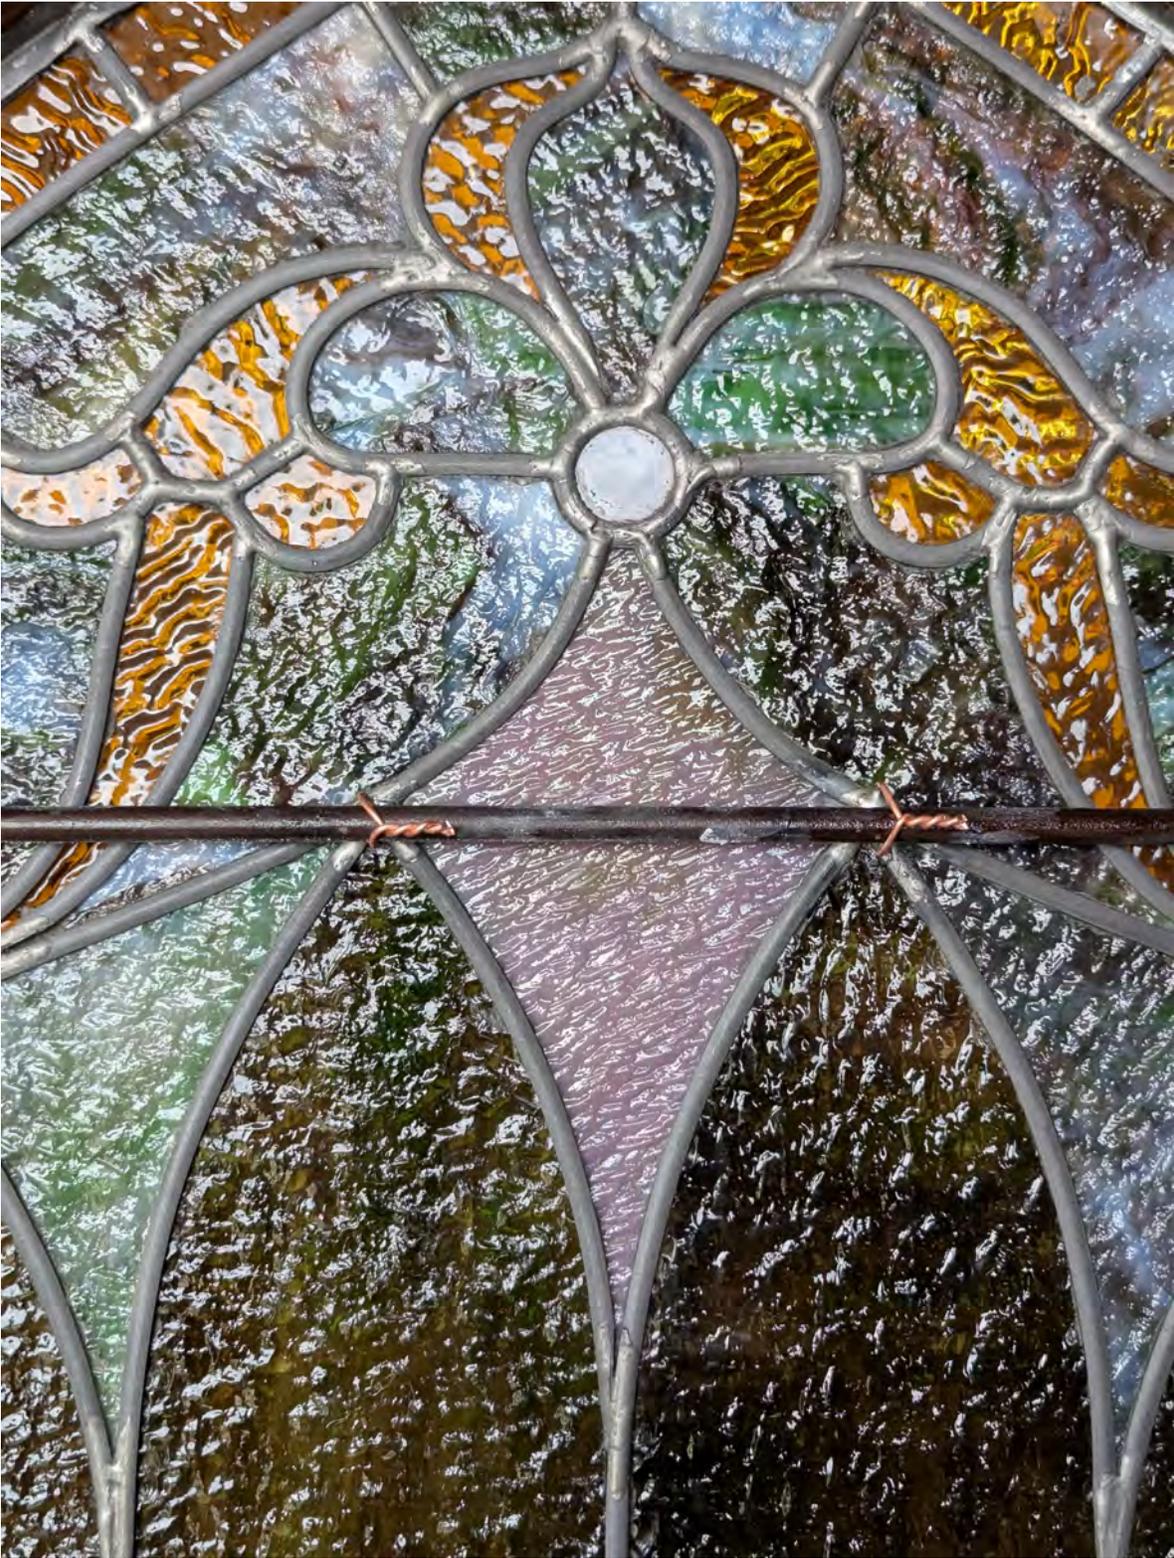
Figure 30: The new copper wires were then secured to the rebars.

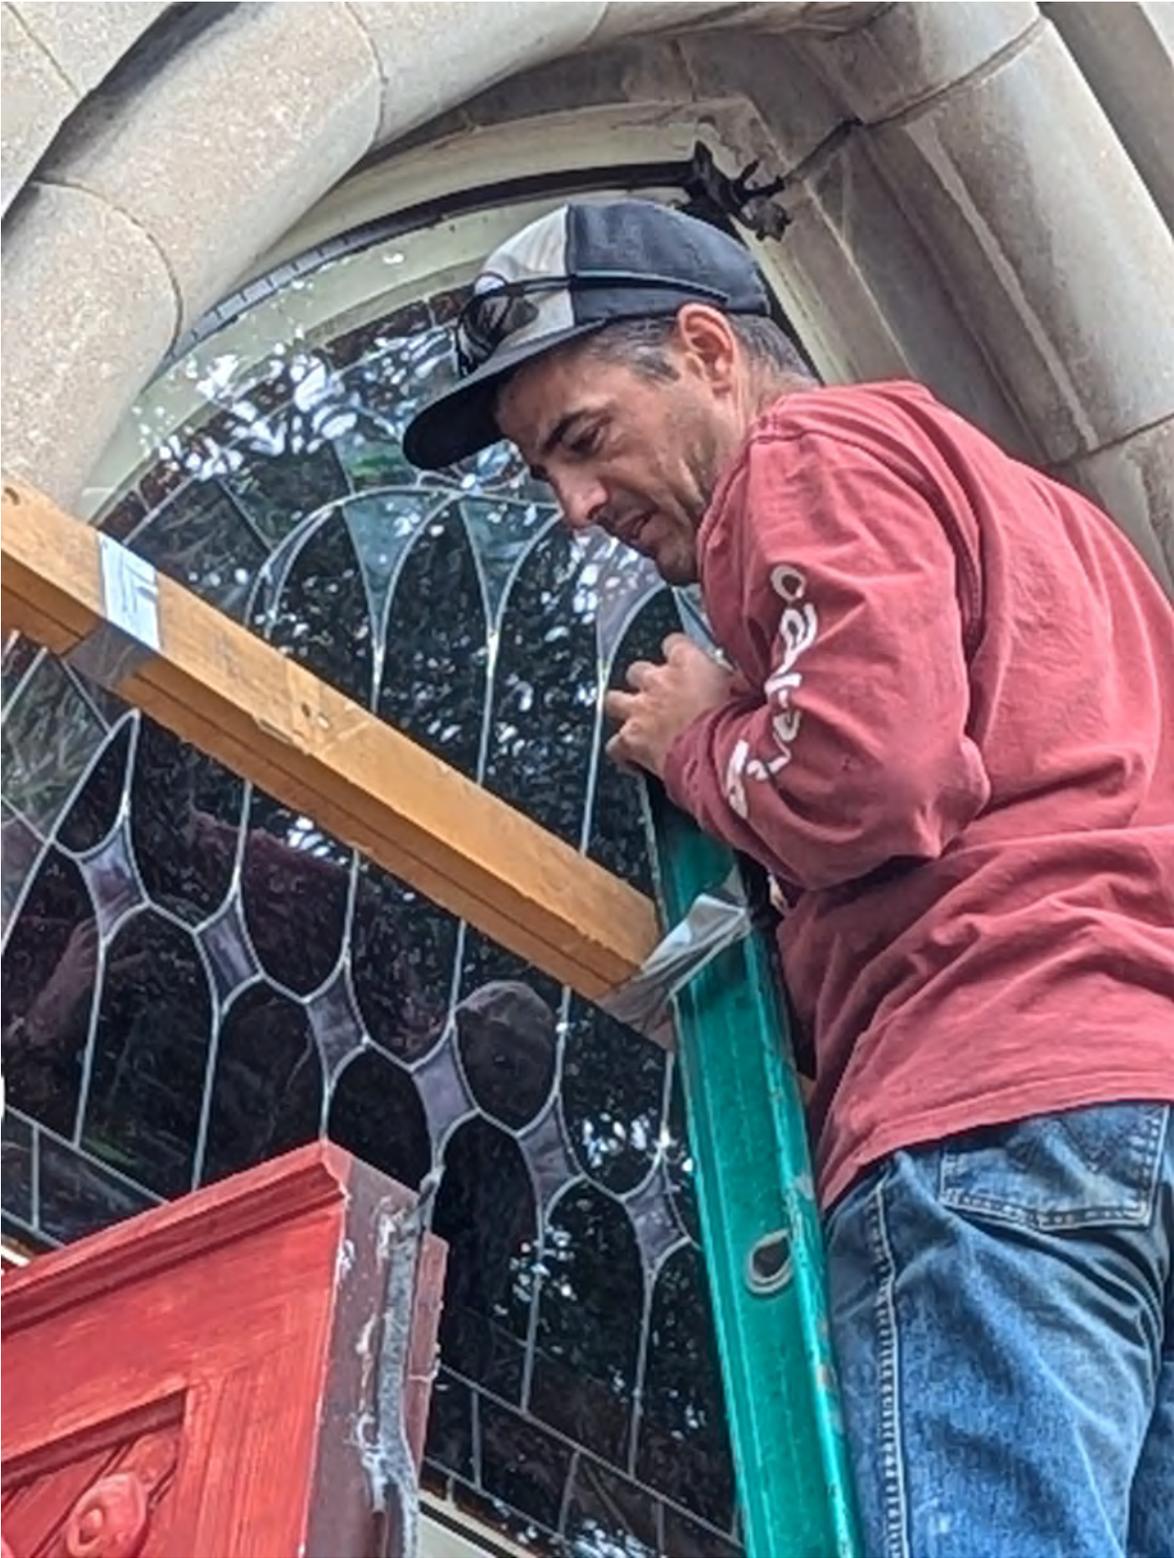
Figure 36: Parishioners: Erik Hefner, Fr Dcn Matthew Swiggum, Clay Zierk, and Evgheni Ilovan carefully lifted and re-installed fragile stained-glass piece. See [06 Sep](#)
